Prestressed Concrete Bridges
Condition Assessment and Future Challenges
A State-of-Art Report

BBT 2017-011, Trafikverket, TRV 2018/28332, ID 6686

March 14, 2019

Björn Täljsten, Björn Paulsson and Lennart Elfgrén

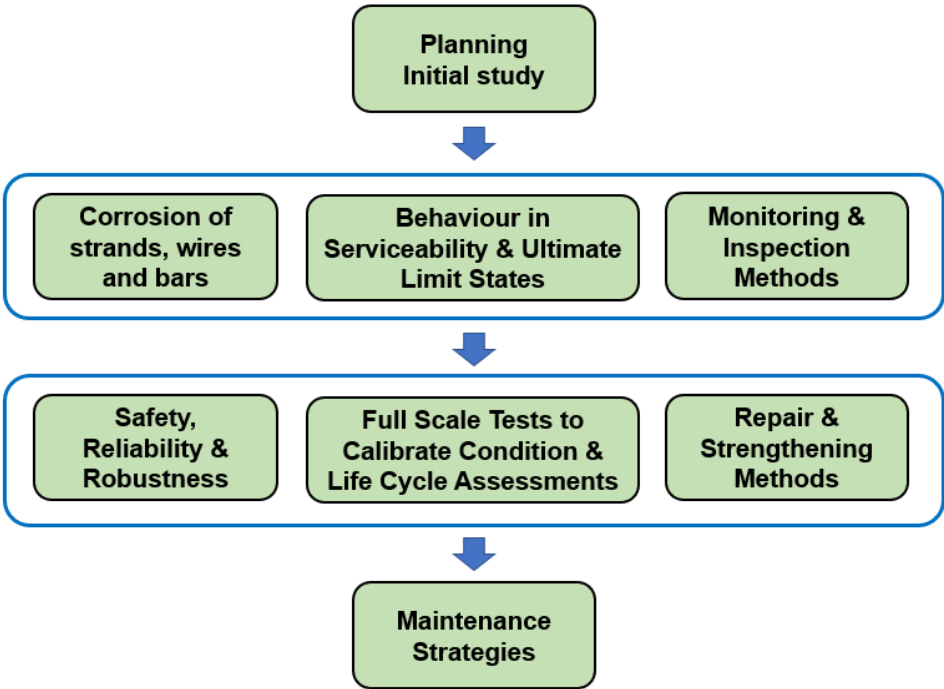
Figure 1.1. Outline of a possible way to structure investigations in different areas which need to be explored for prestressed concrete structures. This report can be seen as an initial State-of-Art in order to map the need for such investigations

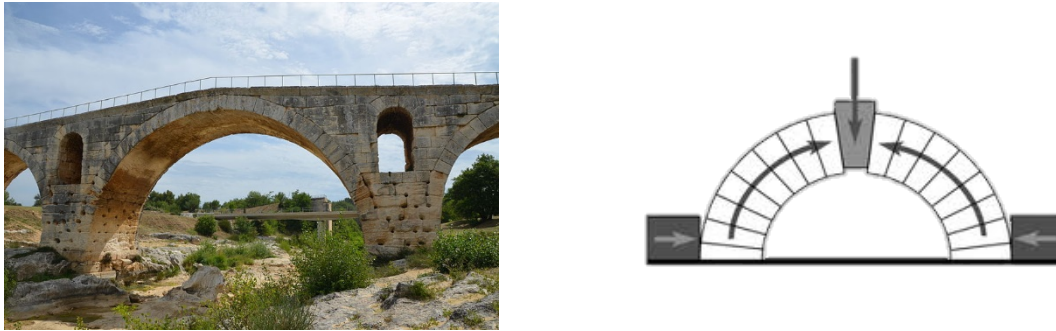
Figure 2.1. Load-bearing principle for an arch with mainly compressive stresses, www.wikimedia.org and Nilsson (2014).

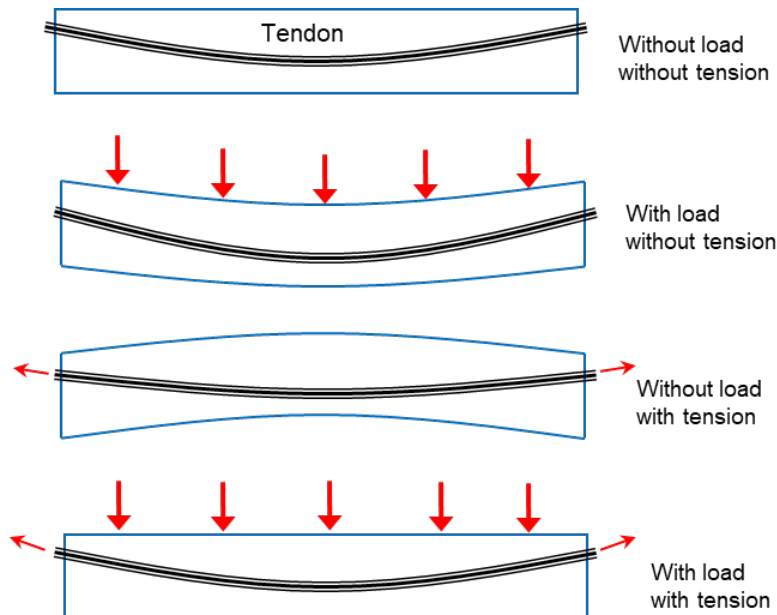
Figure 2.2 Principle for the behavior under load of a concrete beam without and with post-tensioned reinforcement, based on (Phoenix7777 - <https://commons.wikimedia.org>)

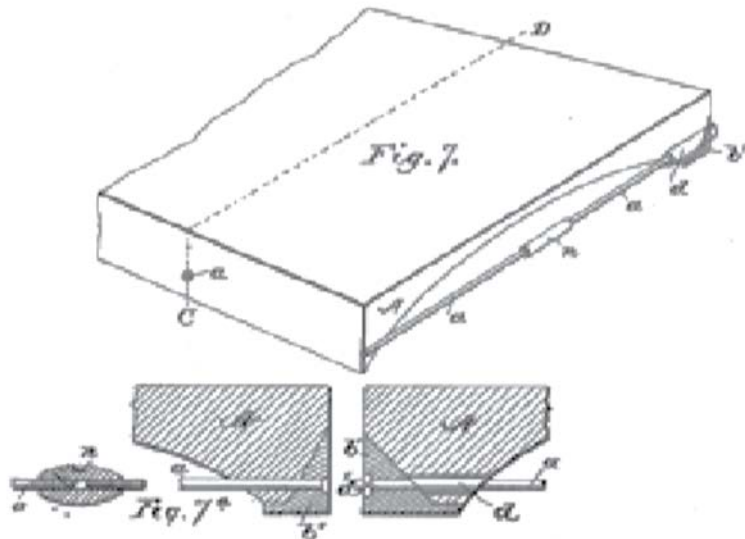
Figure 2.3. Prestressed concrete floor by P. H. Jackson, U.S. Patent 375999 (1888), Sanabra-Loewe & Capellá-Lloera (2014),

In 1888 Peter H Jackson registered a patent in the US on prestressing of a concrete floor using bars anchored with nuts or wedges, Sanabra-Loewe & Capellá-Lloera (2014), see Figure 2.3.

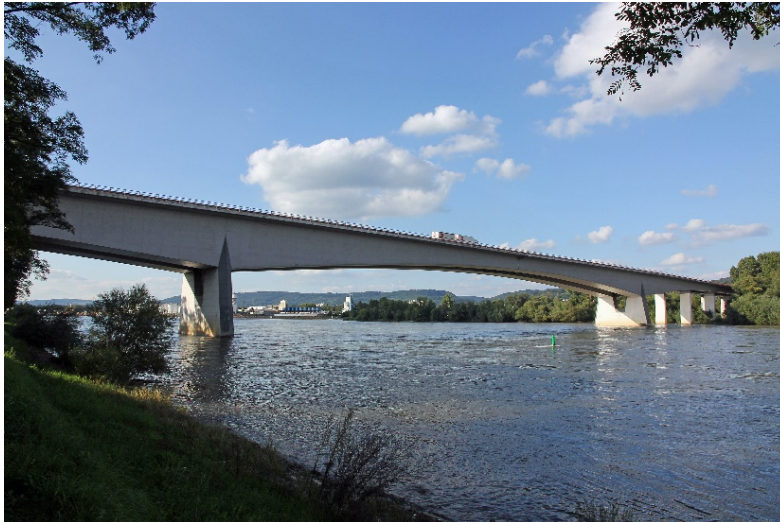
Figure 2.5. Free cantilevering bridge with a span of 202 m from 1962 by Ulrich Finsterwalder. Rhine near Bendorf and Koblenz Photo by Holger Weinandt 2014, Wikipedia.

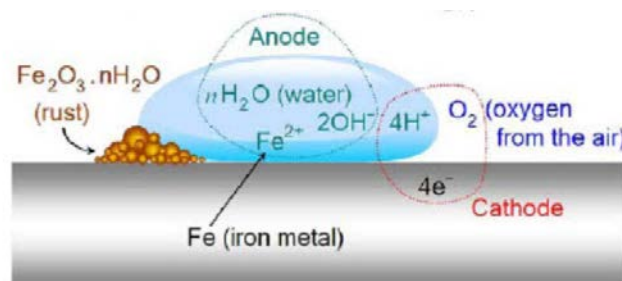
Figure 3.1 Corrosion principle. At the anode the iron loses electrons: $\text{Fe} \rightarrow \text{Fe}^{2+} + 2\text{e}^-$ and at the cathode the oxygen absorbs the electrons: $\text{O}_2 + 4\text{e}^- + 2\text{H}_2\text{O} \rightarrow 4\text{OH}^-$. The ferrous ions then react with the hydroxyl ions: $\text{Fe}^{2+} + 2\text{OH}^- \rightarrow \text{Fe}(\text{OH})_2$ and the ferrous hydroxide forms together with oxygen hydrated ferric oxide (rust): $4\text{Fe}(\text{OH})_2 + \text{O}_2 \rightarrow 2\text{Fe}_2\text{O}_3 + 4\text{H}_2\text{O}$. From Total Materia (2011)

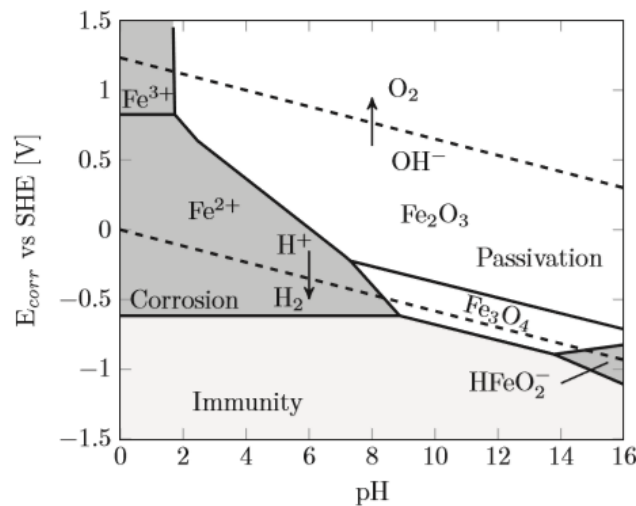
Figure 3.2. Corrosivity for iron, Fe , in water at 25°C for different potential and pH combinations. Pourbaix (1973), Berrocal (2017).

A graphical representation of the thermodynamically stable regions of an aqueous electrochemical system for different potential and pH combinations for iron is illustrated in Figure 3.2 in a so called Pourbaix diagram, Pourbaix (1973), Berrocal (2017). In it three different thermodynamic corrosion regions can be identified: an immunity region, a passivity region and an active corrosion region. From the diagram in Figure 3.2 it can be observed that at very low potentials, the steel is in the immunity region, which means that corrosion is not thermodynamically favored. When potentials increase, for very high pH values, as is the case with the pore solution of concrete, the steel is in the passivity region. This means that under high alkalinity conditions, a very thin, dense and stable iron-oxide film is formed on the surface of the steel. This film, often referred to as the passive layer, greatly reduces the ion mobility between the steel and surrounding concrete; thus, the rate of corrosion drastically drops and becomes negligible.

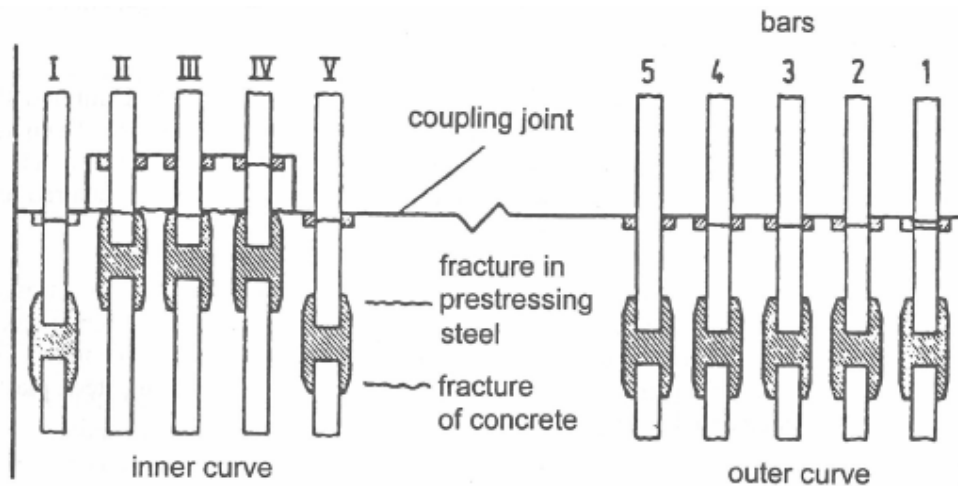
Figure 3.3. Location of Dywidag $\phi 26$ mm prestressing tendons and adaptors and development of fracture in the area of the coupling joint in Heerdtter Dreieck.in Düsseldorf 1977. fib Bull 26 (2003).

The use of cable couplers in construction joints of prestressed concrete bridges in order to transfer the prestressing force is a normal practice. In a study in Germany, damage was observed in some 1200 out of 2200 examined bridges, many in the form of a zone of cracking close to the coupling sections. Among other things, these cracks gave rise to an increased stress range in the tendons and a fatigue failure of a construction joint with a cable coupler was observed in a ten-year-old bridge in Heerdtter Dreieck in Düsseldorf in 1977, see Figure 3.3, fib Bull 26 (2003). Two separate prestressed concrete bridges formed a flyover at the Heerdtter crossing. The bridge decks were cast in place as continuous single-hollow-core girders. As the longitudinal prestressing, single smooth tendons made of 26mm diameter bar of steel grade St 850/1050 (yield stress $f_y = 850$ MPa, ultimate strength $f_u = 1050$ MPa) were used. At section joints the tendons were coupled with threaded connections using sleeve couplers. In 1976 on one of the bridges fly overs (built in 1956), increased crack widths were clearly visible in the bottom plate at several coupling joints in the curved region. Fine cracks ($w < 0,2$ mm), which had been detected earlier increased in widths up to 2 mm. Gamma-ray inspection confirmed that brittle fracture of the tendons in the lowest parts of the web was the reason for the cracks, Pfohl (1979), Kordina (1981),

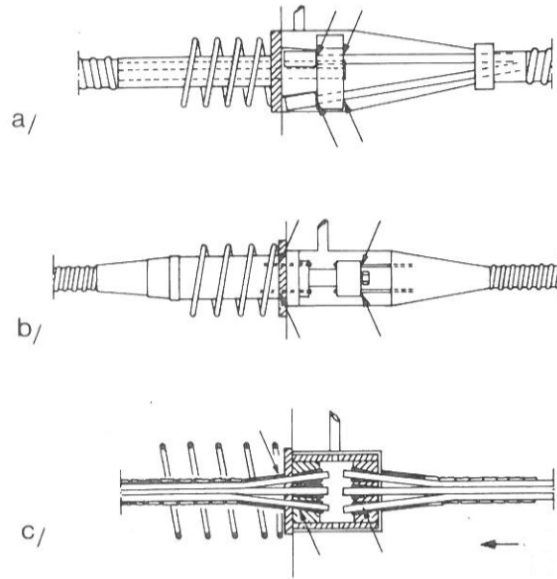
Figure 3.4. Cable couplers of standard type tested in fatigue: (a) VSL 3φ13 mm; (b) BBRV 6φ12 mm; (c) Freyssinet 6φ13 mm (here used with only 3 strands). The arrows indicate fatigue failure. From Emborg (1988).

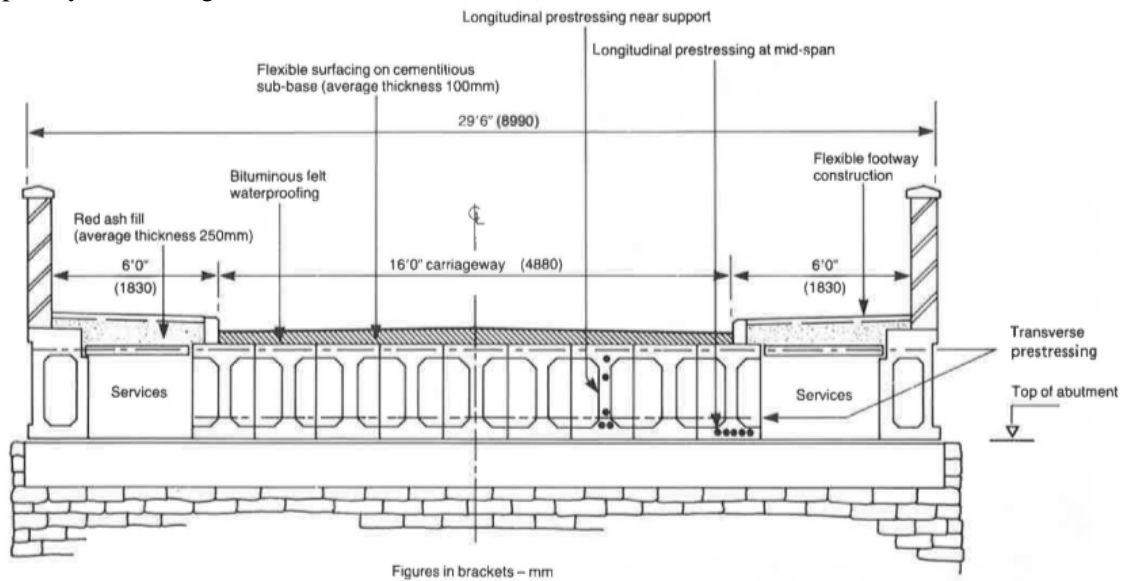
FIGURE 1 Cross section of Ynys-y-Gwas bridge (1953–85).

Figure 3.5. Cross-section of bridge in Wales which collapsed in 1985. Woodward (1989)

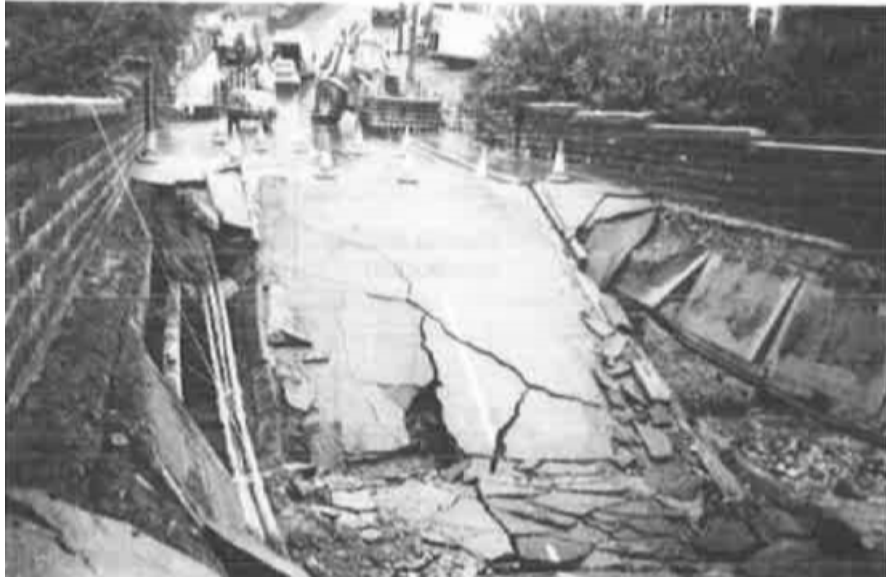
Figure 3.6. Collapse of bridge in Wales 1985. Woodward (1989).

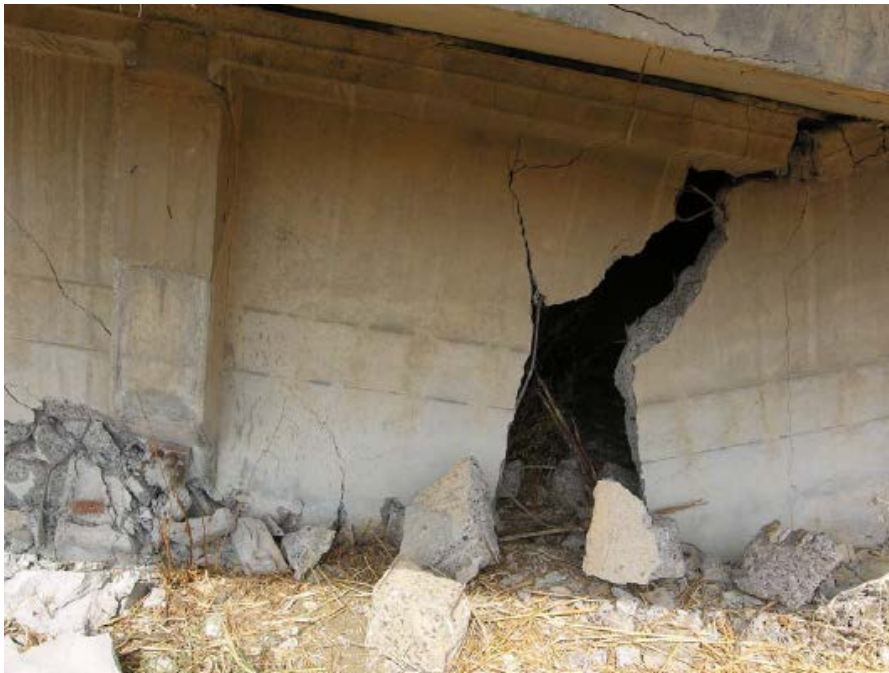
Figure 3.7. Mid-span fracture of prefabricated prestressed beams in Sicily in 2014, Anania et al (2018).

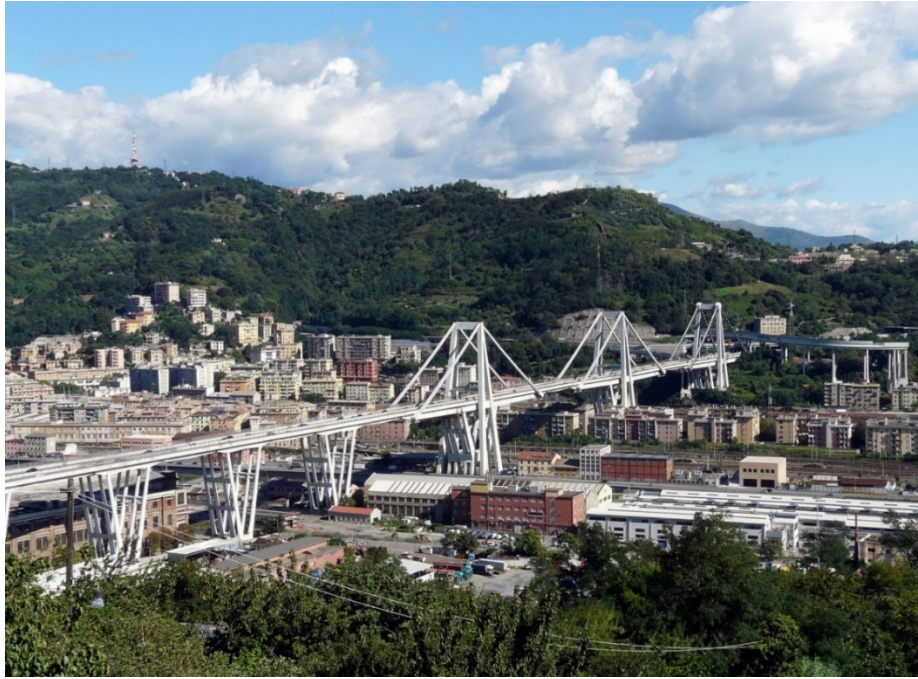
Figure 3.8. The Polcevera bridge in Genoa, Italy, from 1967, designed by Ricardo Morandi, partly collapsed on August 14, 2018. A cable stay broke in the tower to the left in the picture, probably due to corrosion and fatigue caused by cracks in the prestressed concrete supposed to protect it, see Figure 3.9. Photo by Davide Papalini, <https://commons.wikimedia.org/w/index.php?curid=11542499>

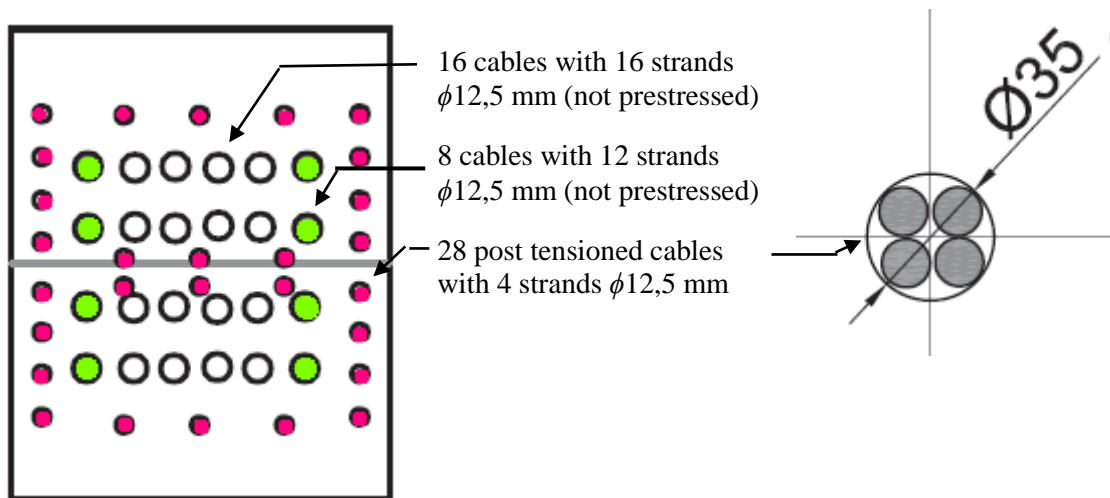
Figure 3.9. Detail of the concrete encased cable stays (0,98 x 1,22 m) in the Morandi (Polcevera) bridge in Italy. The outer small red circles mark 28 post-tensioned cables consisting of 4 strands $\phi 12,5$ mm in $\phi 35$ mm ducts. Each strand consists of 7 wires $\phi 4$ mm. The cables were used to apply a compressive stress of originally $\sigma_c \approx - 8.7$ MPa on the concrete. However, at maximum live load it turned into a tensile stress of $\sigma_c \approx 1.6$ MPa, enough to crack the concrete and start corrosion in the cables. Creep and shrinkage of the concrete widened the cracks during the years. The $\phi 35$ mm ducts are quite narrow making it hard to inject them to protect the cables. This may have resulted in voids facilitating the corrosion. Modified from Calvi et al. (2018).

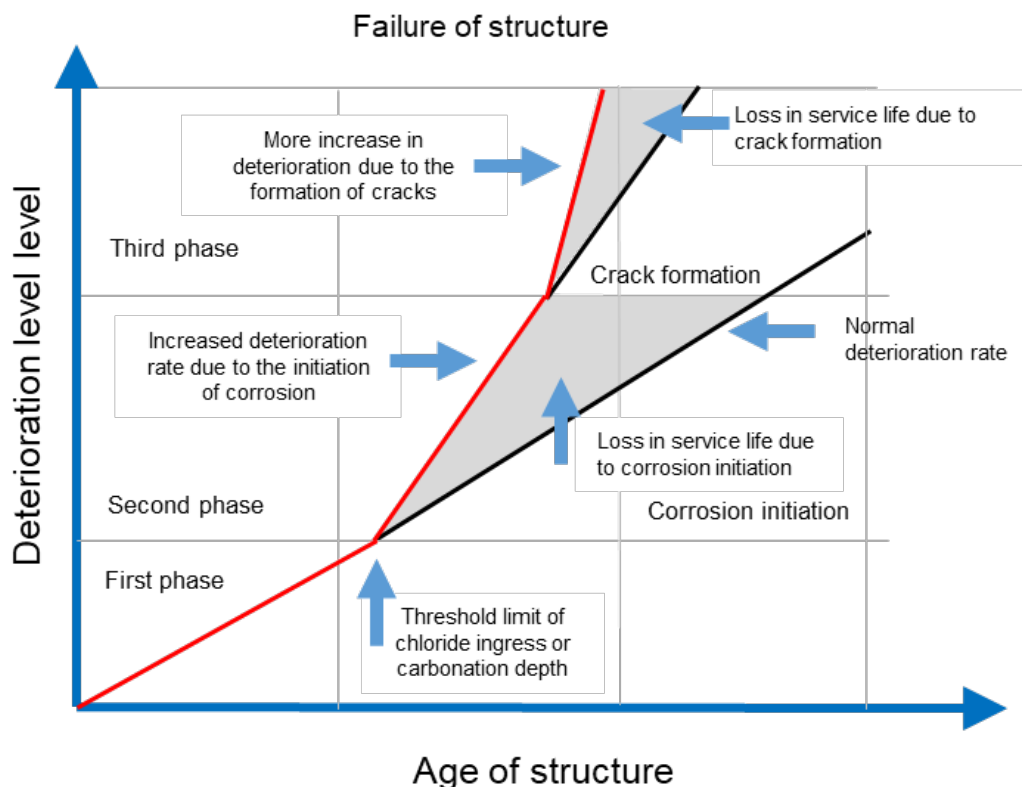
Figure 3.10 General deterioration phases for a concrete structure, based on Al-Neshawy et. al.,(2016)

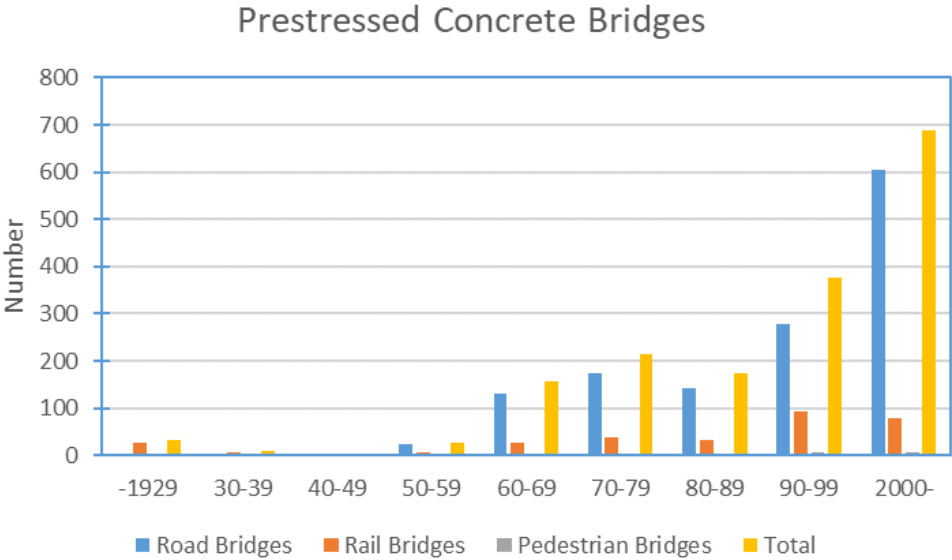
Figure 4.1 Age distribution and number of prestressed concrete bridges in the bridge stock of Trafikverket (BaTMan)

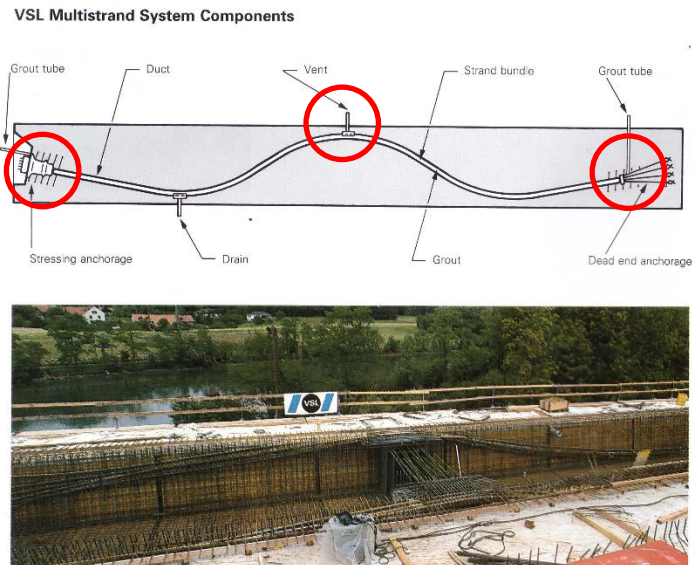
Figure 4.2. Example of critical points in wires in a post-stressed beam with anchors, ducts, drains and ventilation (VSL 1975)

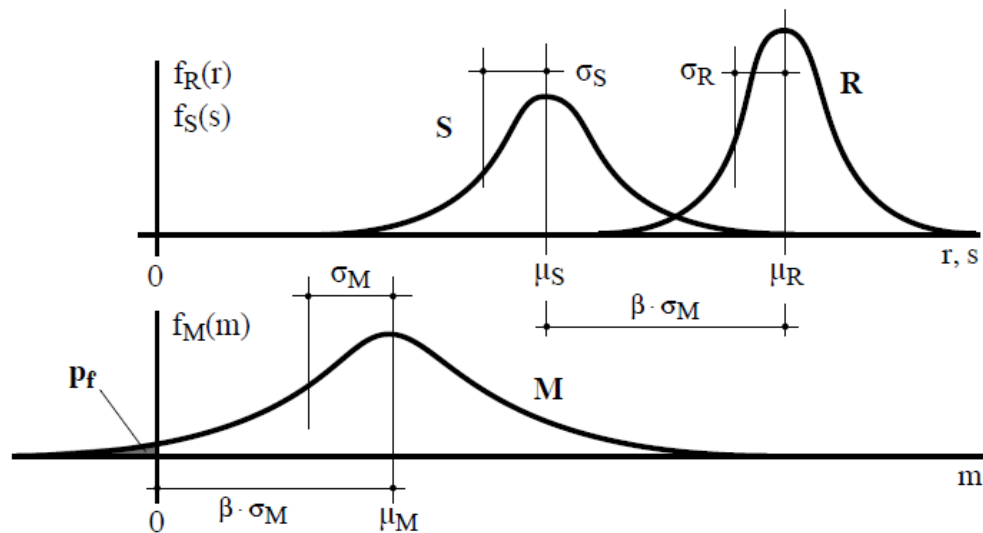
Figure 5.1. Frequency functions $f_R(r)$, $f_S(s)$ and $f_M(m)$ for resistance (**R**), load effect (French: *sollicitation*) (**S**) and safety margin (**M** = **R** – **S**) as functions of the resistance (r), the load (s) and the margin (m). For the bending capacity of a bridge slab we may assume the mean value of the resistance to be $\mu_R = 15$ (MNm), of the load to be $\mu_S = 9$ and then the margin will be $\mu_M = \mu_R - \mu_S = 15 - 9 = 6$. We further assume the standard variations to be $\sigma_R = 2$, $\sigma_S = 3$ and then, if the frequencies are supposed to be normally distributed with the areas under the curves to be 1, then $\sigma_M = (\sigma_R^2 + \sigma_S^2)^{0.5} = (2^2 + 3^2)^{0.5} = (13)^{0.5} = 3,61$. The safety margin can be expressed as the number β of standard variations from μ_M to or $m = 0$, that is $\mu_M = \beta \cdot \sigma_M$. In our case we will have the reliability factor $\beta = \mu_M / \sigma_M = 6 / 3,61 = 1,66$. For a normal distribution this means that the probability of failure (the area under the $f_M(m)$ -curve to the left of $m = 0$) will be $p_f = 0,049$ or 4,9 % . Modified from Schneider & Vrouwenvelder (2017).

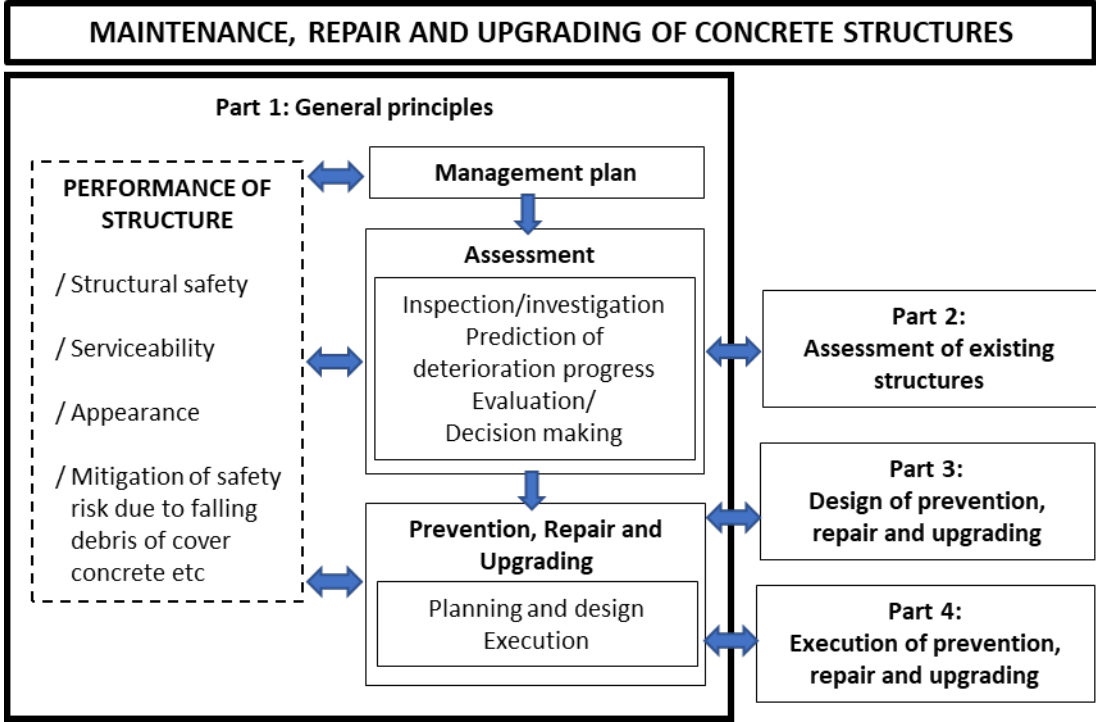
Figure 5.2 General principles for maintenance, repair and upgrading, based on (ISO 16311-1, 2014)

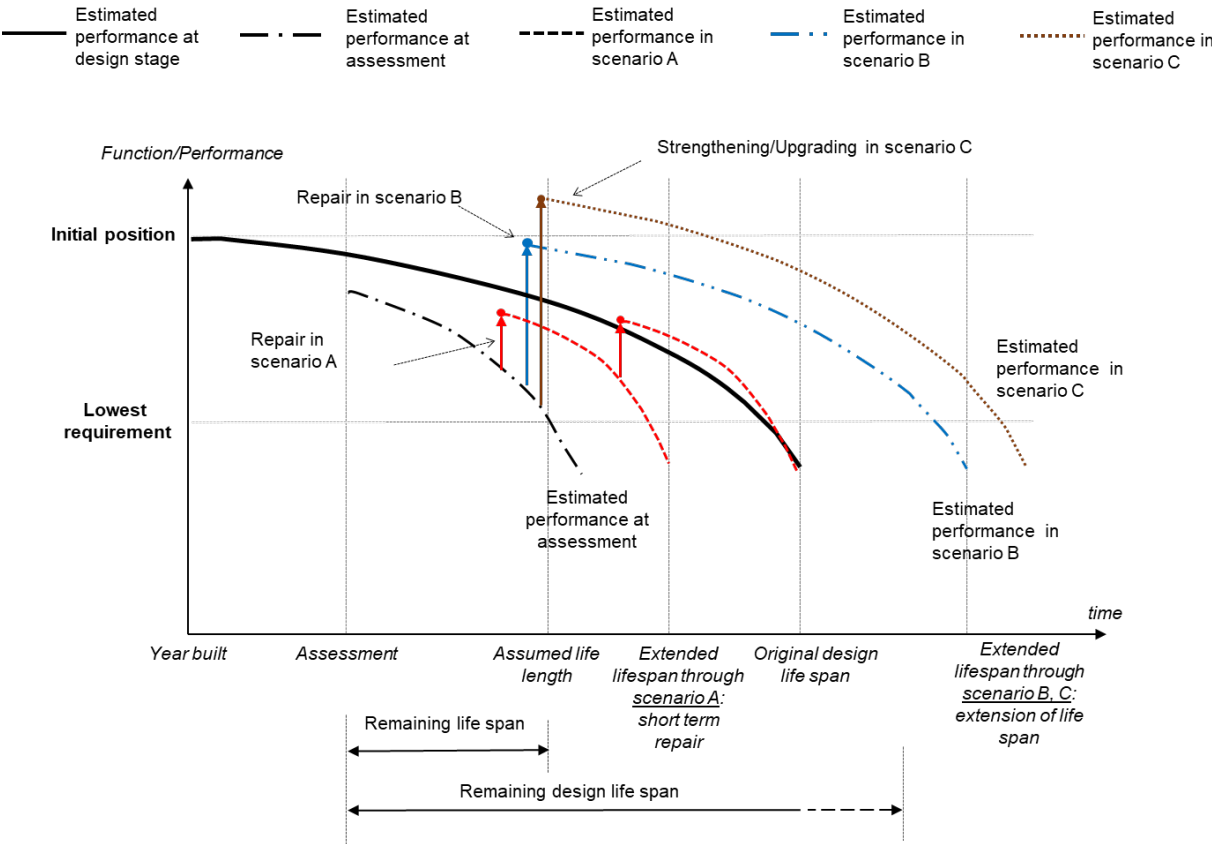
Figure 5.3 Performance of structure, based on (ISO 16311-1, 2014)

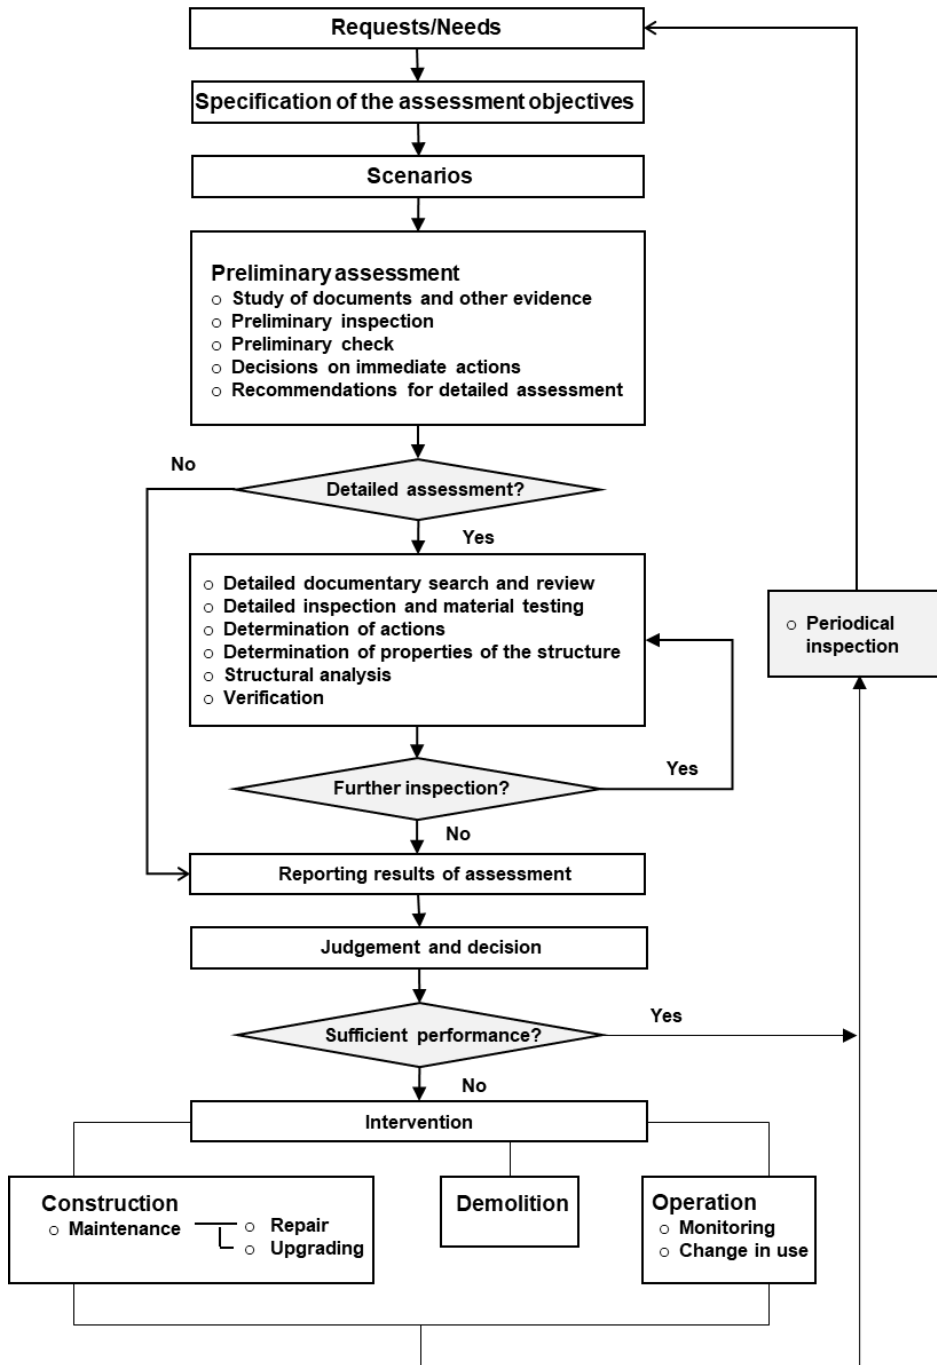
Figure 5.4 General flowchart for assessment of existing structures, based on (ISO 16311-2, 2014, ISO 13822)

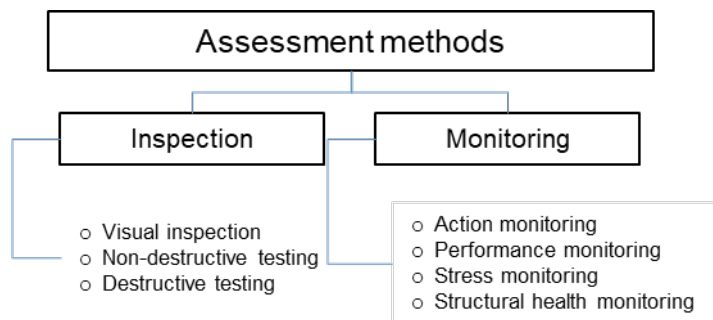
Figure 5.5 General classification of assessment methods, based on (Honfi et. al, 2018)

In general, the assessment methods can be classified into inspection and monitoring, see figure 5.5. Inspection cover visual inspection, non-destructive testing with appropriate systems and methods for the concrete structure studied, see chapter 6, and also destructive testing, which depends in the depth of the investigation. Action monitoring is described as the assessment of a structure’s response in time and space due to a known load and/or studying the load itself. Performance monitoring, on the other hand, allows an assessment of wheather a structural component meets the performance requirements under a known or any load (Honfi etl al, 2018). Stress monitoring is typically used directly in a structural assessment without any intermediate interpretation using a structural model. A SHM (Structural health monitoring) systems objective is to monitor the in-situ behaviour of a structure accurately and efficiently over time, ta assess its performance under various service loads, to detect damage or deterioration, and to determine the health or condition of the structure. The SHM system should be able to provide, on demand, reliable information pertaining to the safety and integrity of a structure. The information can then be incorporated into bridge maintenance and management strategies, and to improve design guide-lines.

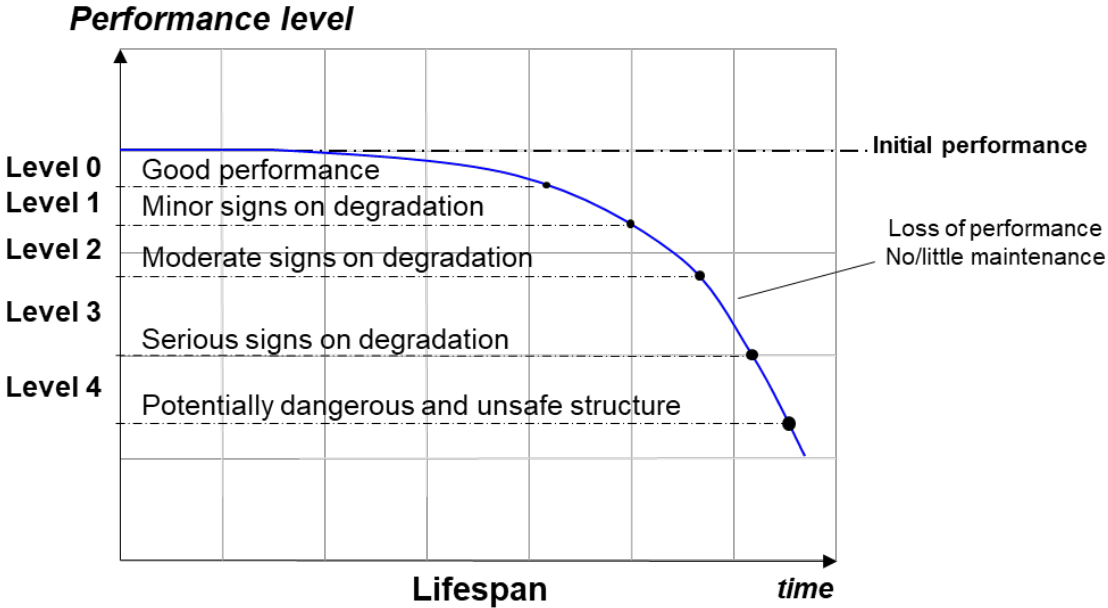
Figure 5.6 Principle illustration of the condition levels, depending on time, based on (ISO 16311-2, 2014)

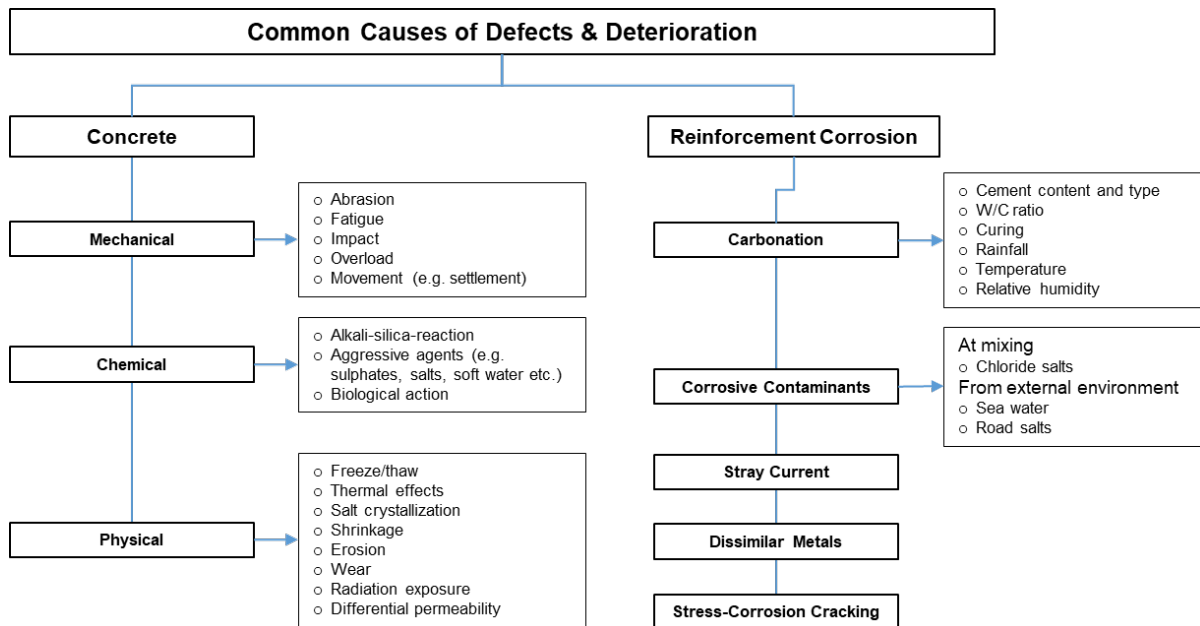
Figure 5.6 Common causes of defects and deterioration of concrete structures, based on (ISO 16311-3, 2014)

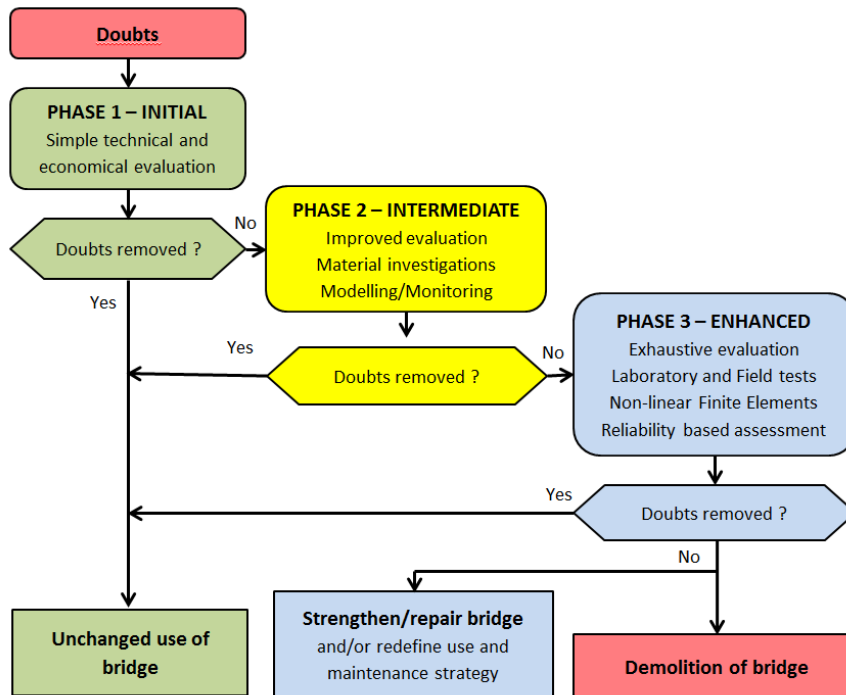
Figure 5.8 Flow chart for the assessment procedure of a bridge with three phases. Based on (Schneider 1994, 2017, Sustainable Bridges 2007, UIC Code 778-4, 2009, ISO 16311-2,2014 and Paulsson et al.2016).

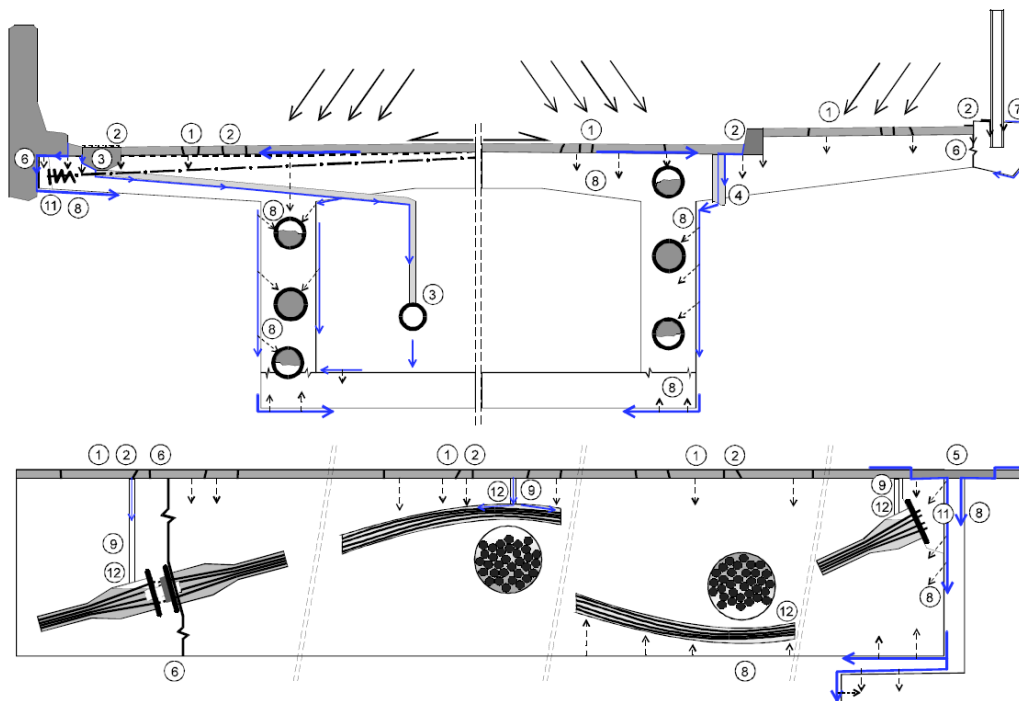
Figure 5.9 Hazard scenarios for prestressed steel in a typical box girder bridge. Indication of potentially weak points where water (possible with chlorides) can gain access to the tendons and cause corrosion (Matt, 2000).

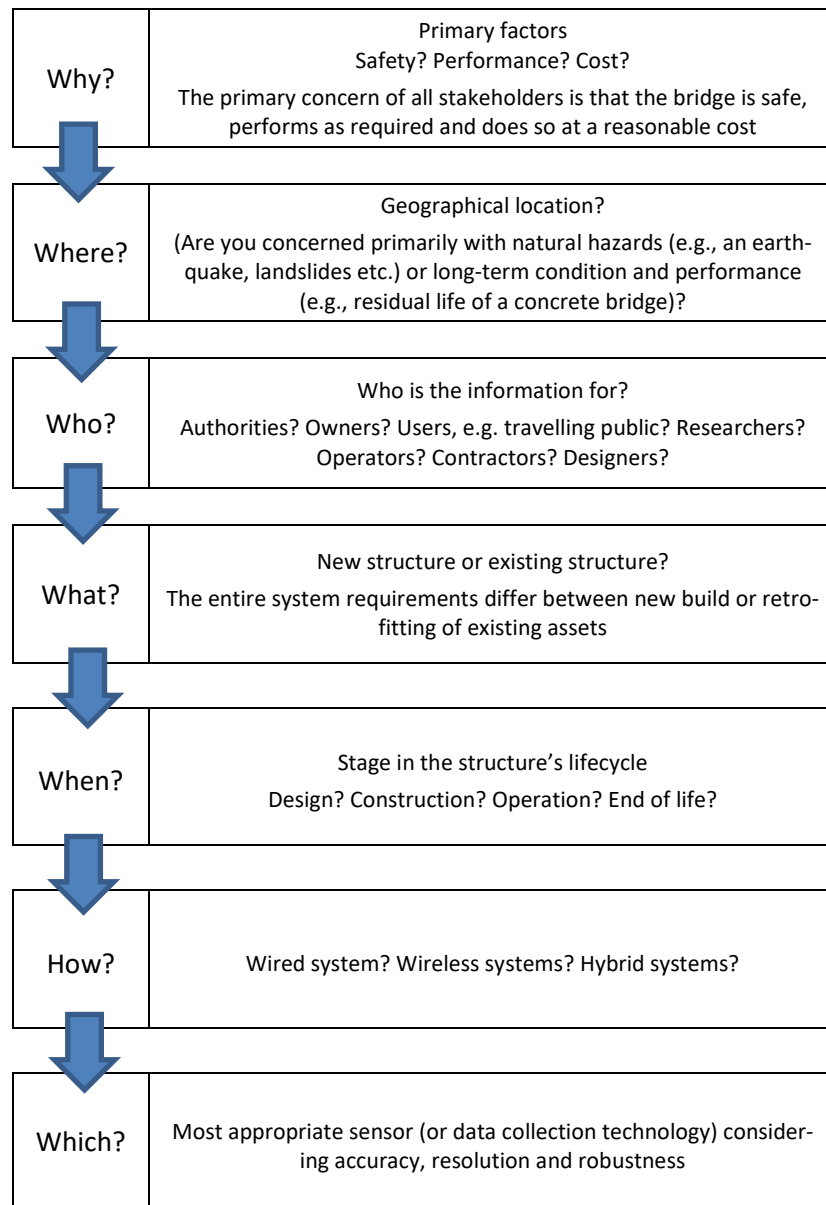
Figure 6.1 Main considerations when examining whether or not to employ a structural health monitoring system, from (Vardanega et. al., 2018)

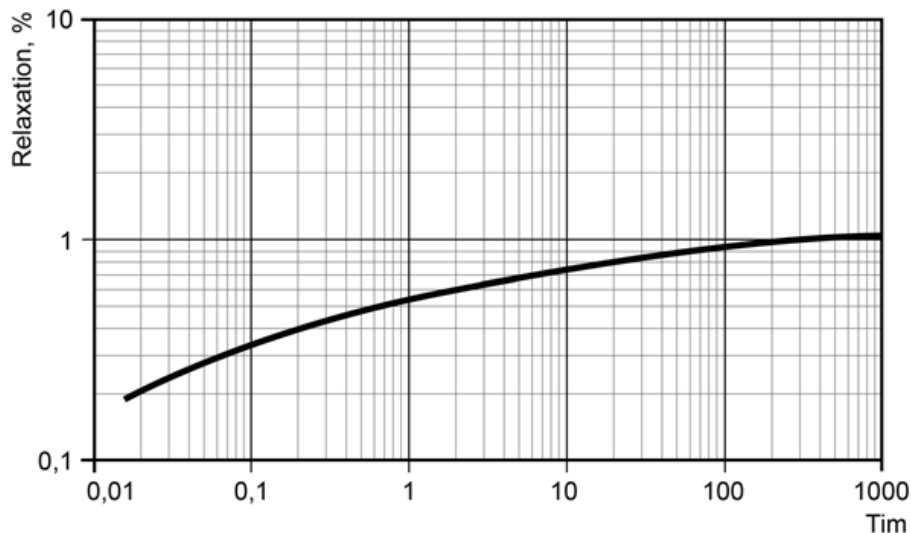
Figure 6.2. Relaxation of a $\phi 12,9$ mm cable prestressed at 20°C to 70 % of the ultimate strength (here 1860 MPa). BHM-I (2017).

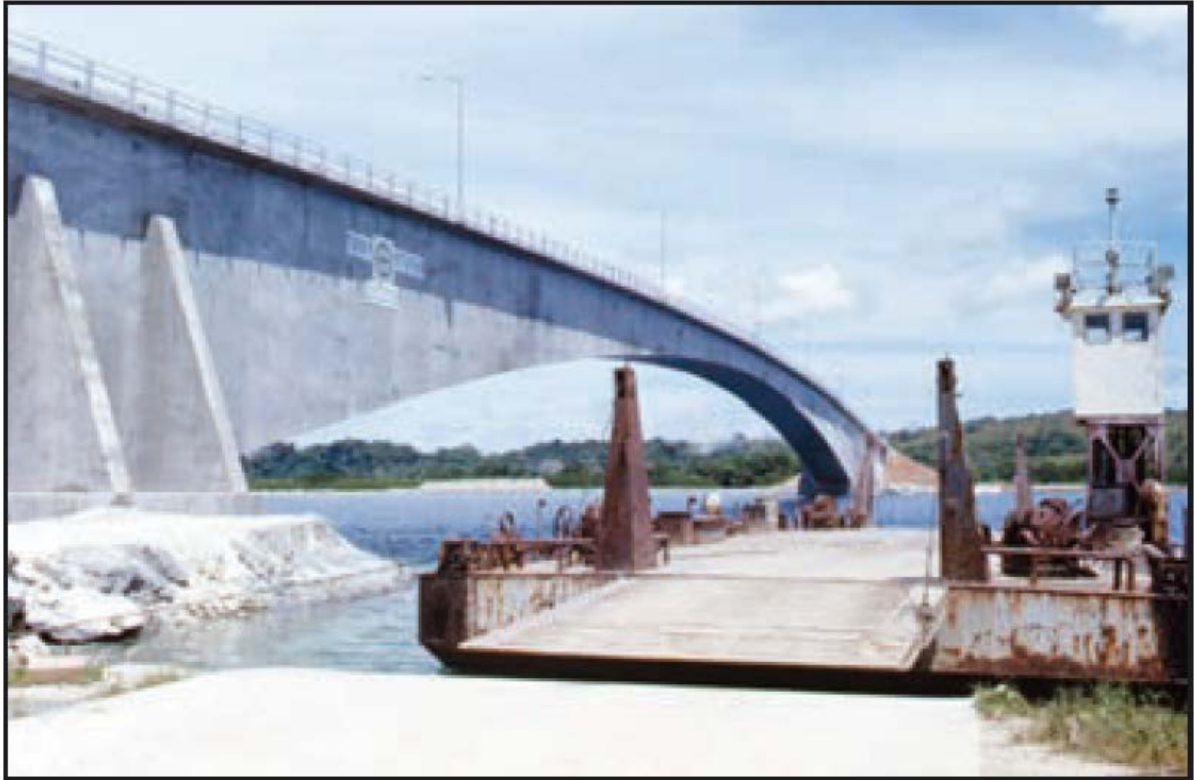
Figure 6.4 The 249 m span of the prestressed Koror bridge (and the ferry it replaced) before failure in 1996 due to creep and relaxation, Tang (2014).

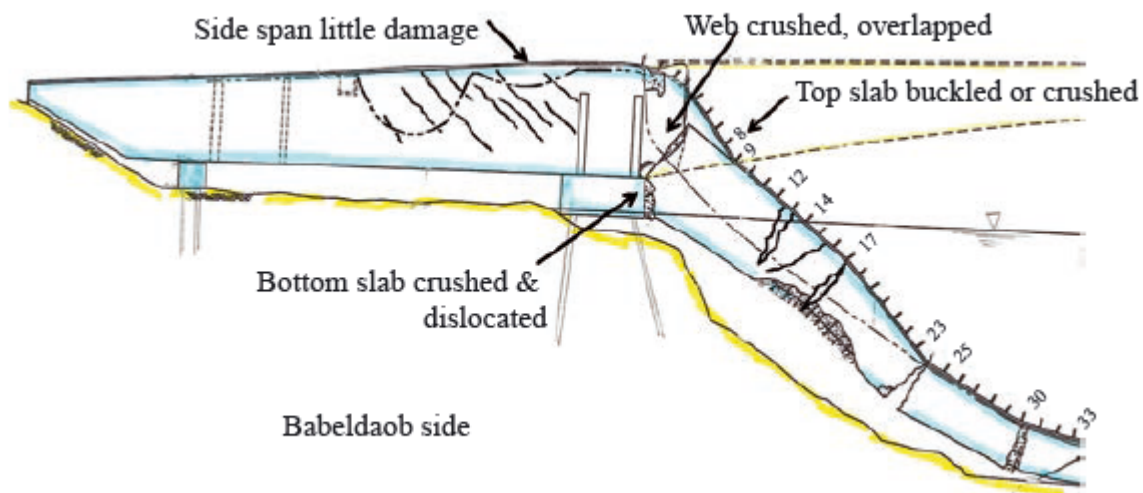
Figure 6.5. Failure of the Babeldaob side of the Koror bridge in Figure 6.4, Tang (2014). The failure was initiated by buckling or crushing of the top slab due to too high compression stresses partly caused by a high temperature in the black asphalt.

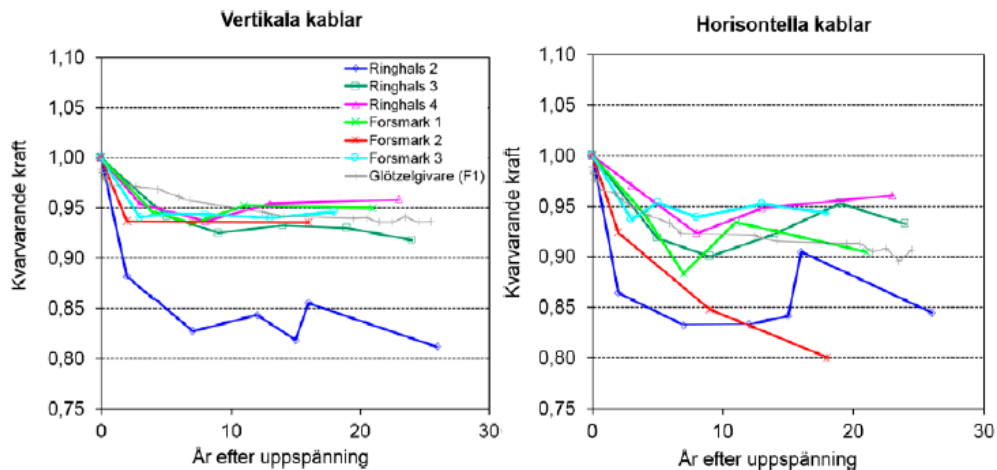
Figure 6.6. Remaining prestressing in relation to the original force for Swedish nuclear reactor containments. The left figure refers to vertical cables and the right to horizontal ones. The vertical axes give the relative remaining force and the vertical axes the time in years. From Andersson (2017).

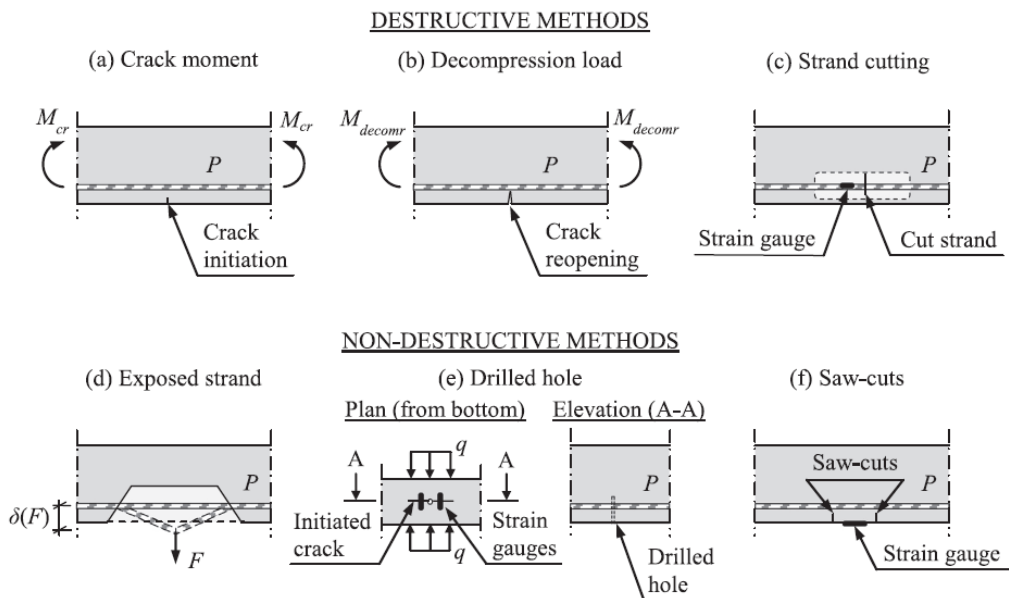
Figure 6.7. Methods to determine residual prestress force P in concrete members experimentally: (a) crack moment method, (b) decompression-load method, (c) strand cutting method; (d) exposed strand method, (e) drilled hole method and (f) saw-cut method, Bagge et al.(2017).

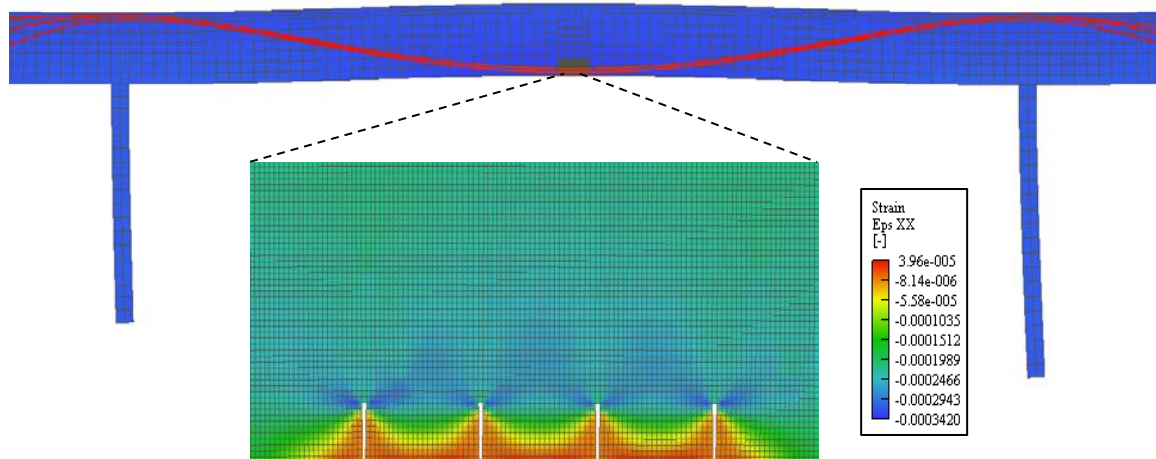
Figure 6.8 A part of an FE model for simulation of the strain distribution as saw-cuts are introduced transversally at the base of a concrete beam (Bagge et al. 2017).
