Prestressed Concrete Bridges
Condition Assessment and Future Challenges
A State-of-Art Report

BBT 2017-011, Trafikverket, TRV 2018/28332, ID 6686

March 14, 2019

Björn Täljsten, Björn Paulsson and Lennart Elfgrén

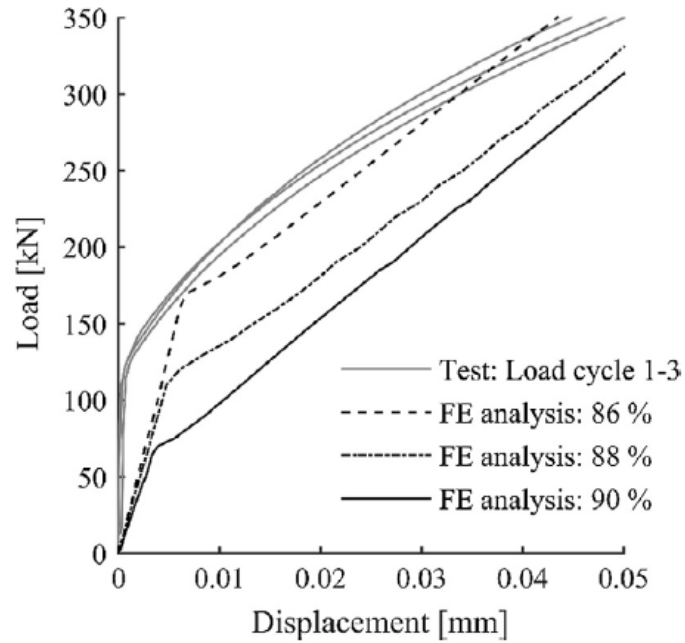
Figure 6.9. Load-displacement behaviour at crack opening according to test at the Kiruna bridge and FE analyses at indicated level of prestress losses, Bagge et al. (2017).

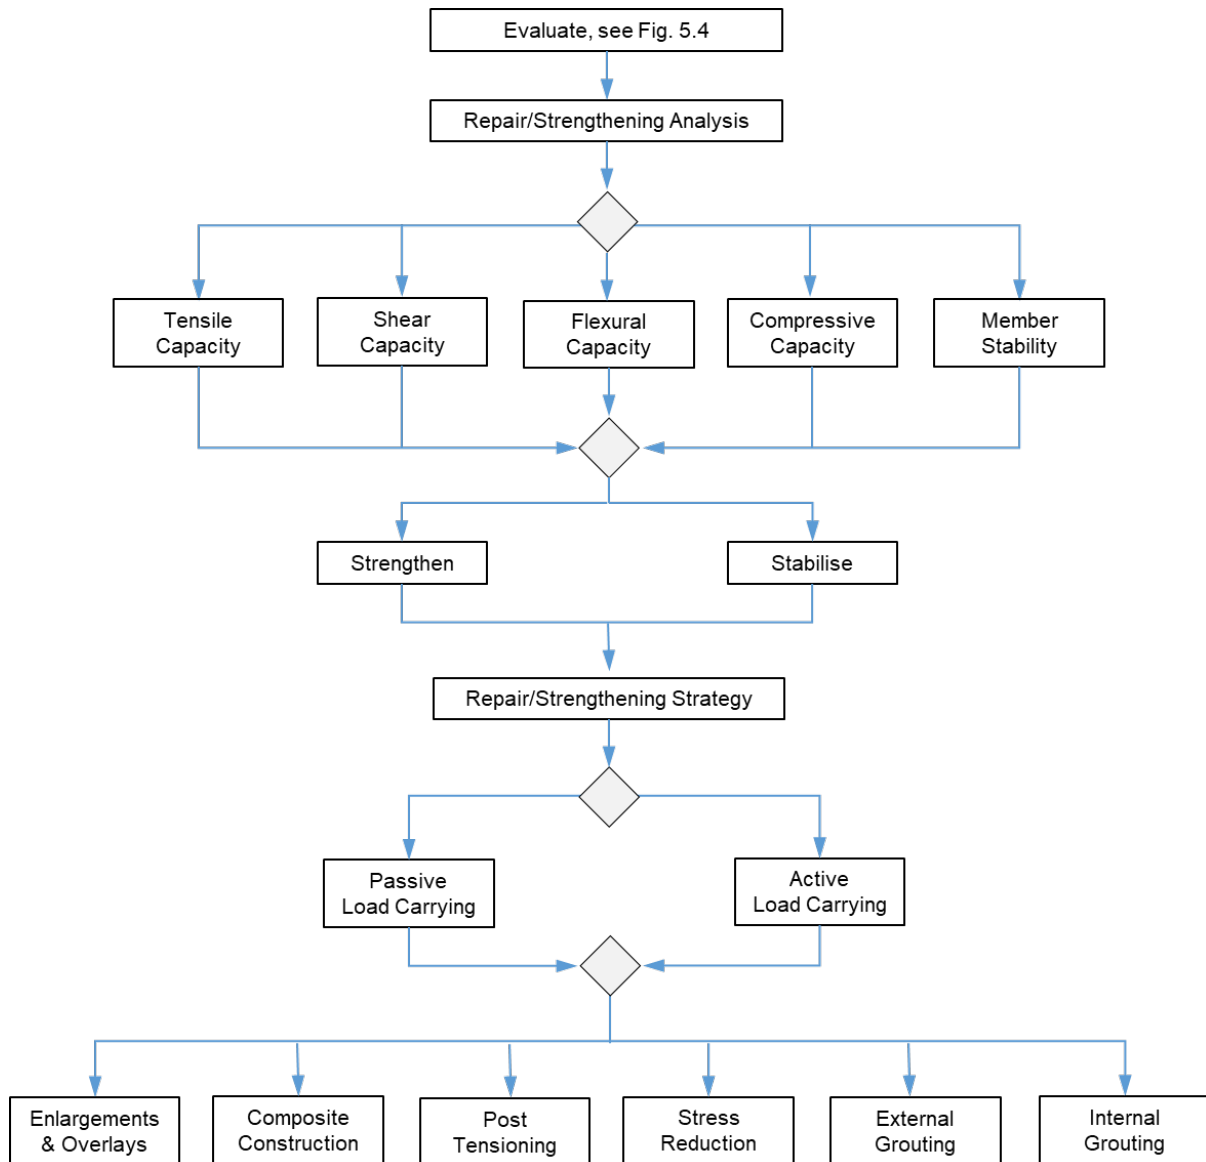
Figure 7.1 General repair and strengthen strategy for concrete structures, based on (Emmons, 1993)

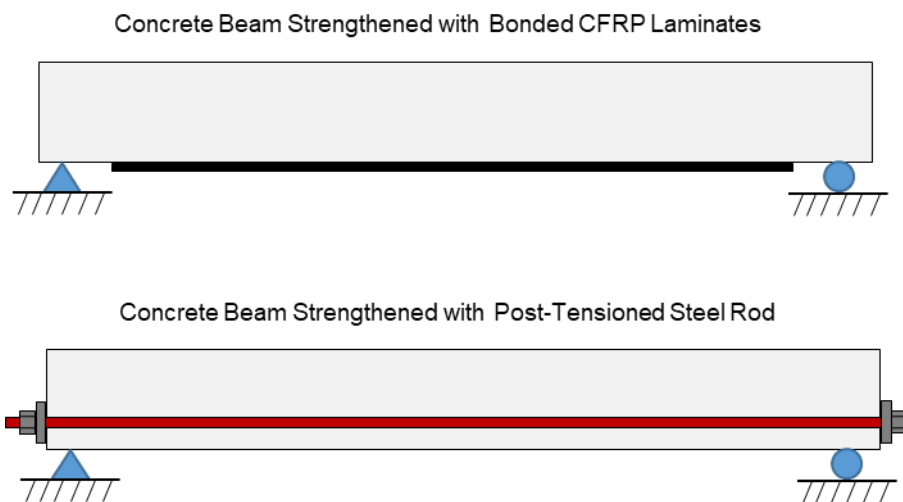
Figure 7.2 Passive and active strengthening

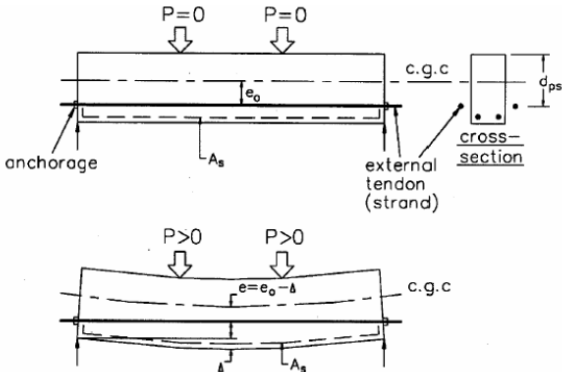
Figure 7.3 Second order effects without deviators, (Tan and Ng, 1997)

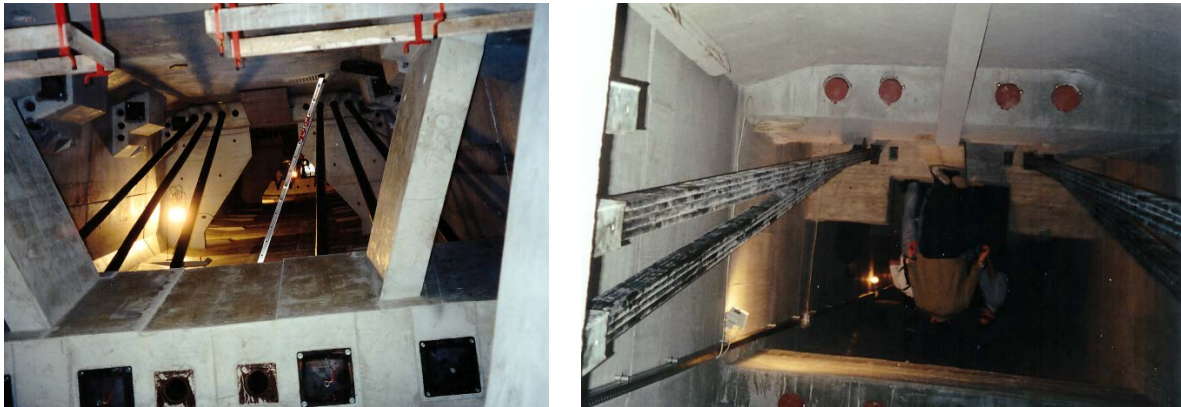
Figure 7.4 External post-tensioning applied to concrete box-girder bridges Photos from a French bridge on high speed line to Marseilles left and a Hungarian bridge on the new freight line through Slovenia to the Mediterranean (Photos by B. Paulsson)

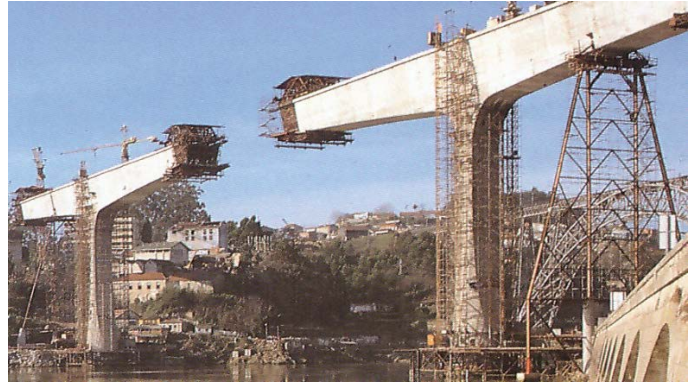
Figure 7.5 Photos from the new railway bridge in Porto shows preparation for extra external post-tensioning, (Nova ponte ferroviaria sobre o Rio Douro no Porto)

In figure 7.4 and 7.5, examples of external post-tensioning of a concrete bridge are shown.

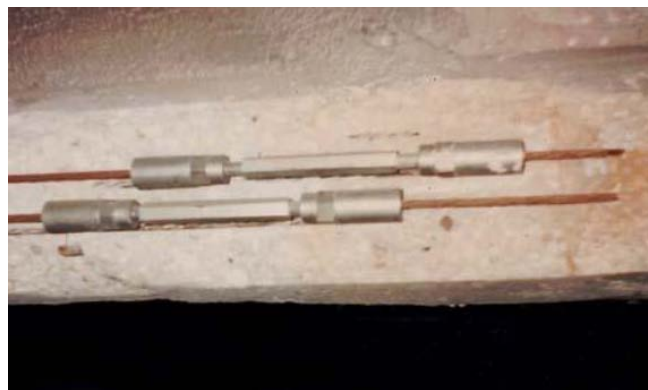
Figure 7.6 Strand splice, (Harris et. al., 2009)

Strand splices are designed to reconnect severed strands (Harris et. al., 2009). Methods of reintroducing prestress force into the spliced strand are preloading, strand heating and torqueing the splice; the latter is most common, essentially making the splice a turnbuckle of sorts. Strand heating is a method whereby the strand is heated, the strand splice is secured to the strand and as the strand is allowed to cool, it shrinks, thus introducing tension back into the strand. Strand heating of conventional high-strength prestressing strand is not believed to be a terribly rational method of affecting any reasonable prestrain: either a) a long length of strand must be heated; or b) a short length of strand must be heated to a high temperature. The former is impractical in a bridge girder and the latter will affect the material properties of the strand. Strand heating is not recommended. Commercially available strand splices have couplers connected to reverse threaded anchors; as the coupler is turned, both anchors are drawn toward each other, inducing a prestress in the attached strand, see figure 7.6. Strand splicing are normally not used for internal post tensioning systems.

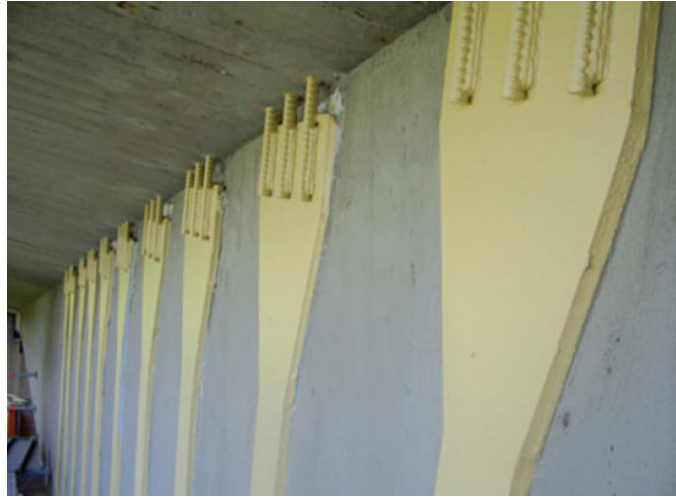
Figure 7.7 Shear strengthening of a concrete bridge in Germany (Rose and Kerkeni, 2010)

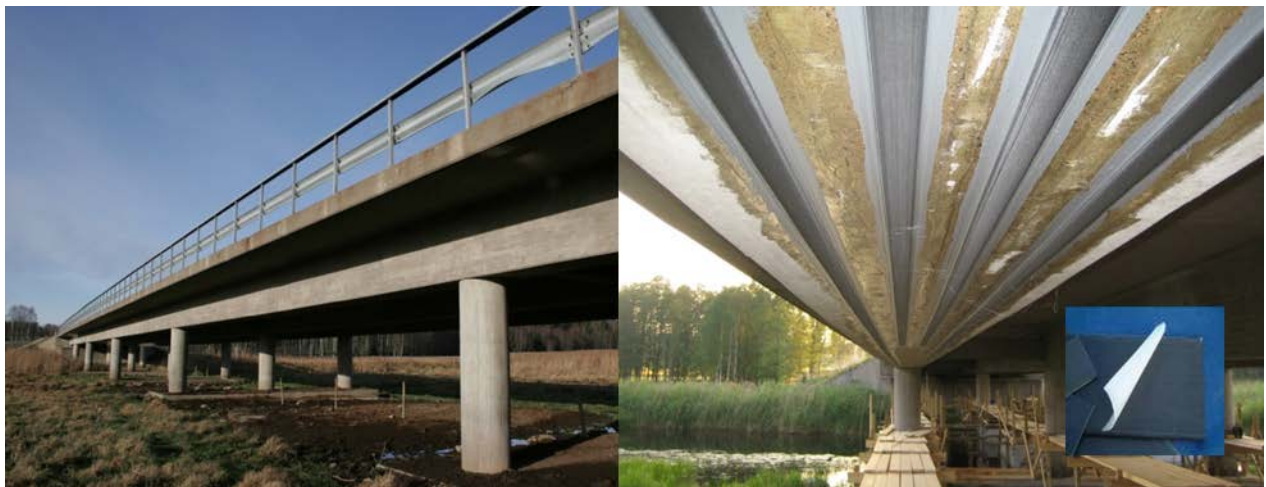
Figure 7.8 Passive strengthening with CFRP laminates, (Photo B. Täljsten)

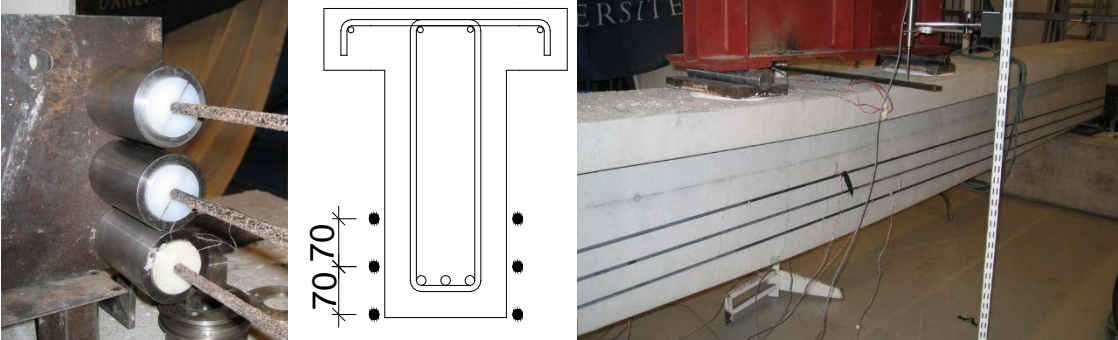
Figure 7.9 Active strengthening with CFRP rods, (Bennitz, 2011)

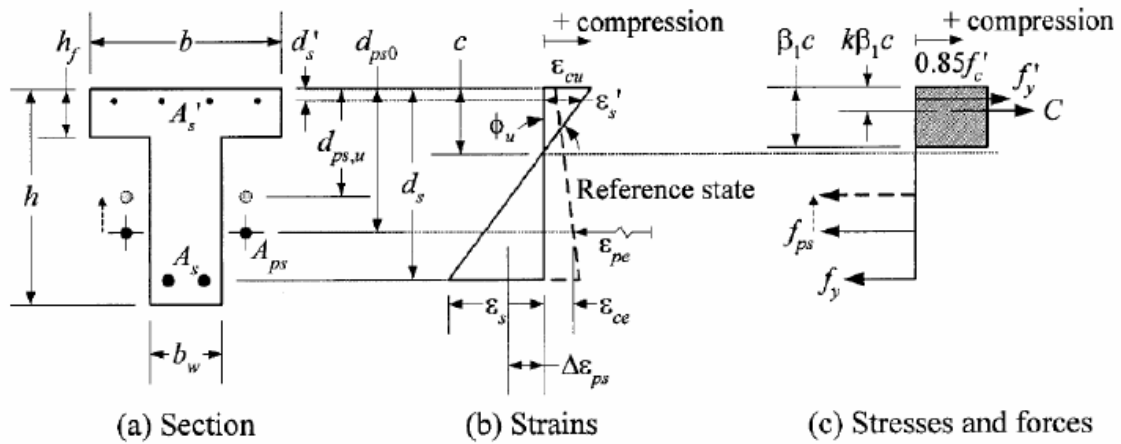
Figure 7.10 Strain and stress distribution at critical section of externally prestressed beam at ultimate limit state, (Ng, 2003)

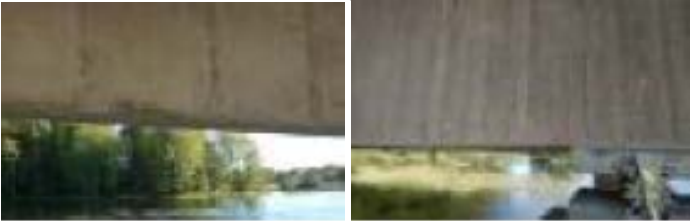
Pictures of damages (BaTMan 2018)

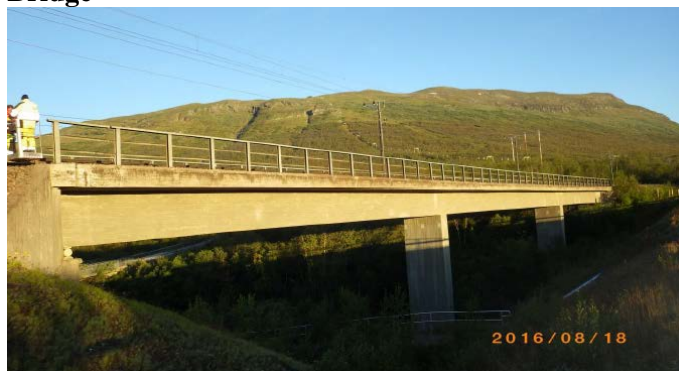
Picture of Abisko bridge (WSP report in BaTMan)

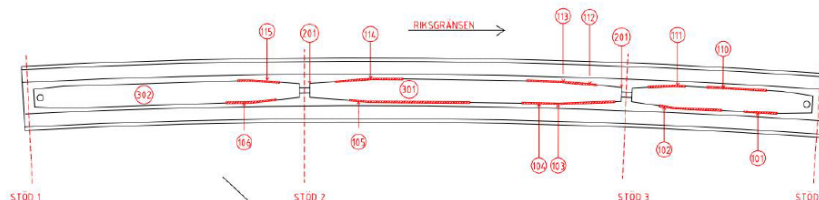
Figure A3 shows all cracks and how they were documented both with locations and on photos.

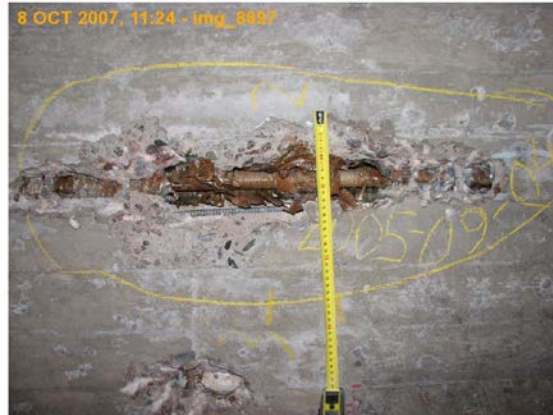
A picture above is from the special inspection showed a bar that had no grouting and some corrosion.

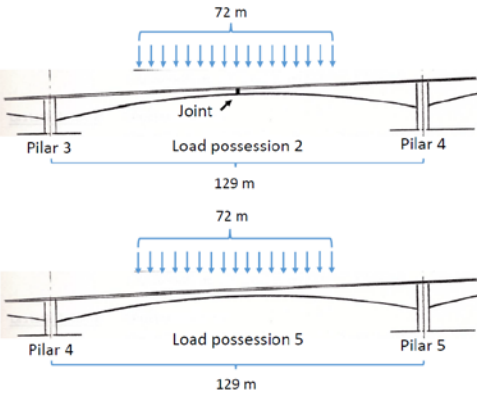
<p>Figure A5 shows the possession of the loading (Paulsson 2018) Table A.2 The table is extracted from original calculations (Paulsson 2018)</p>

Designer	AB Skånska Cementgjuteriet
Contractor	AB Skånska Cementgjuteriet
Assessment information	<p>The bridge was test-loaded in 1978. Below you can see an example of the result.</p>

Load tests on Angeredsbron Gothenburg		
Load position 2 with a joint pillar 3 to 4		
Section	Calculated value (mm)	Measured value (mm)
3.125	-11	-8
3.250	-28	-23
3.375	-50	
3.500	-76	-66
3.625	-52	-39
3.750	-30	-26
3.875	-13	-10
Load position 5 with no joint pillar 4 to 5		
4.125	-10	-7
4.250	-21	-18
4.375	-34	-28
4.500	-39	-36
4.625	-36	
4.750	-24	
4.875	-10

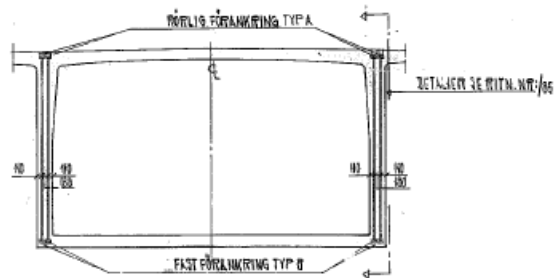
TVÄRSSEKTION 1:50

Figure A7 From drawings (BaTMan 2018)

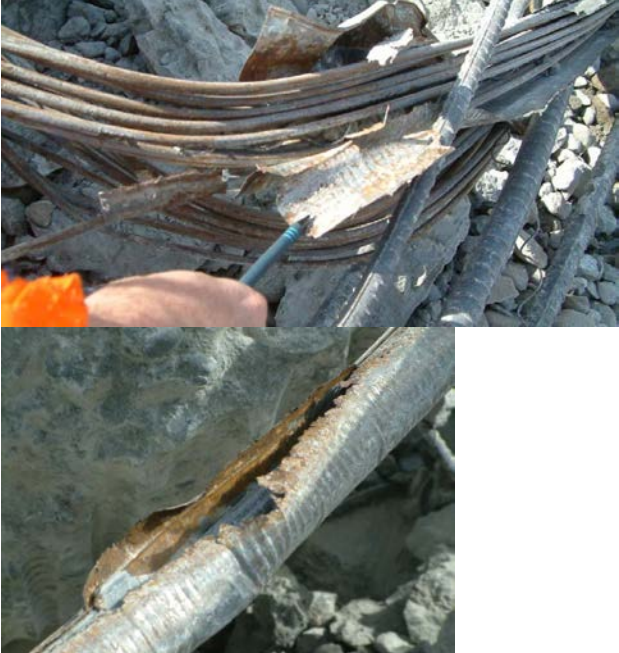
<p>Pictures from the bridge showing cables (KIMAB 2006)</p> <p>From the visual inspection the vires were found not corroded. When looking more closely by experts corrosion was found. Therefore 6 vires was chosen and tested. The figure below clearly shows that the vires with corrosion have a brittle fracture while the other have ductile fracture. This behaviour corresponds well to Mechanical Behaviour Dowling 1999.</p>

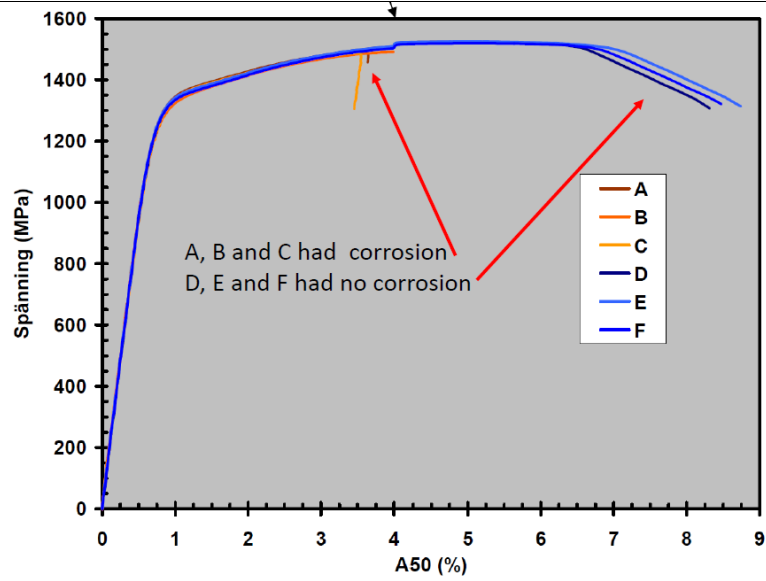
Figure A8 result of tests done by KIMAB 2006

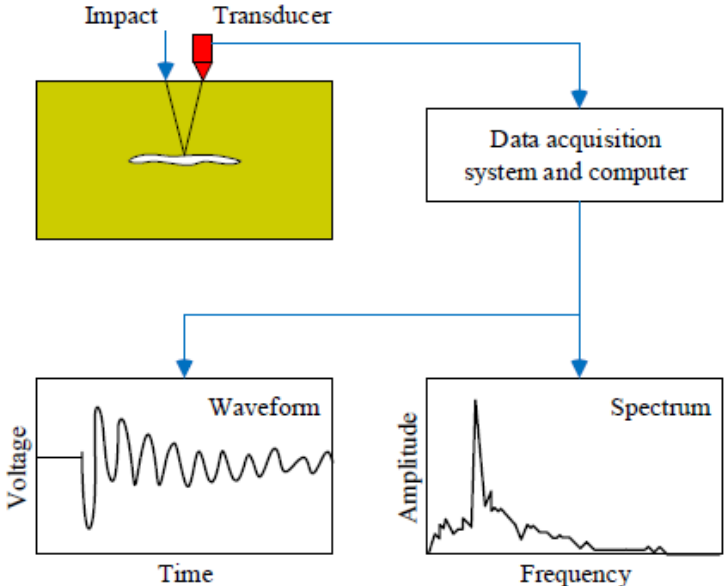
Figure B.1 Simplified diagram of the IE-method (from www.ndt.net)

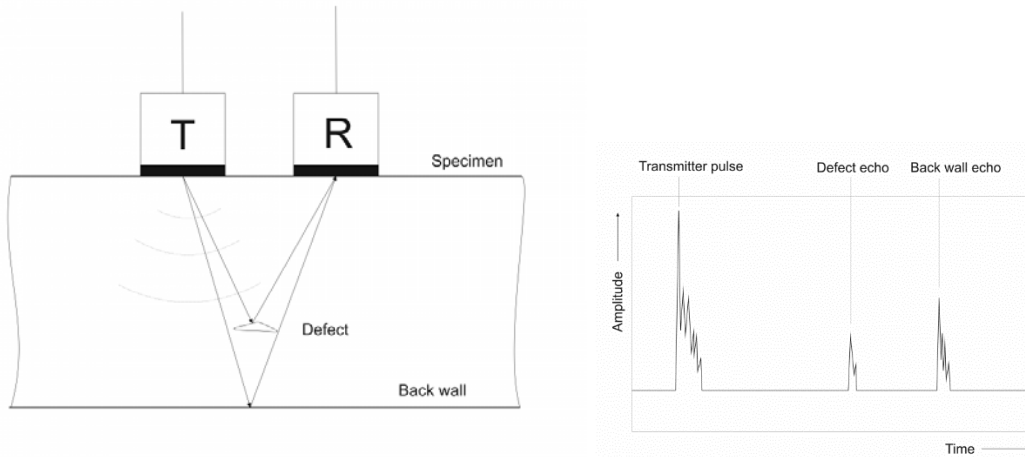
Figure B.2 Simplified diagram of the UPE-method (from www.ndt.net, zfp.cbm.bgu.tum.de)

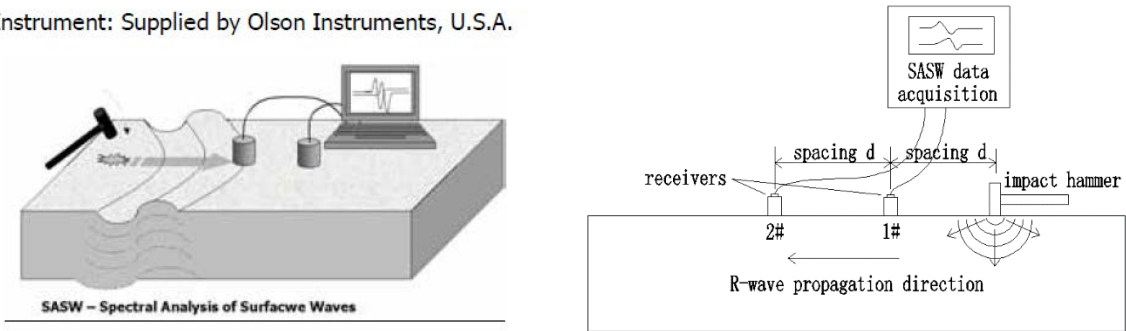
Figure B.3 Simplified diagram of the SASW-method (from www.mdpi.com)

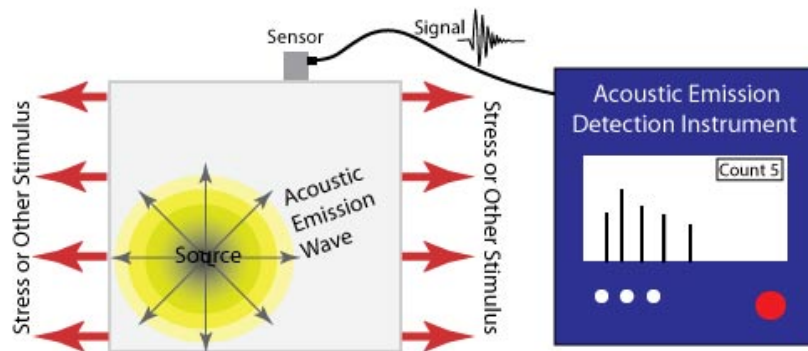
Figure B.4 Simplified function of the AE-method (from www.nde-ed.org)

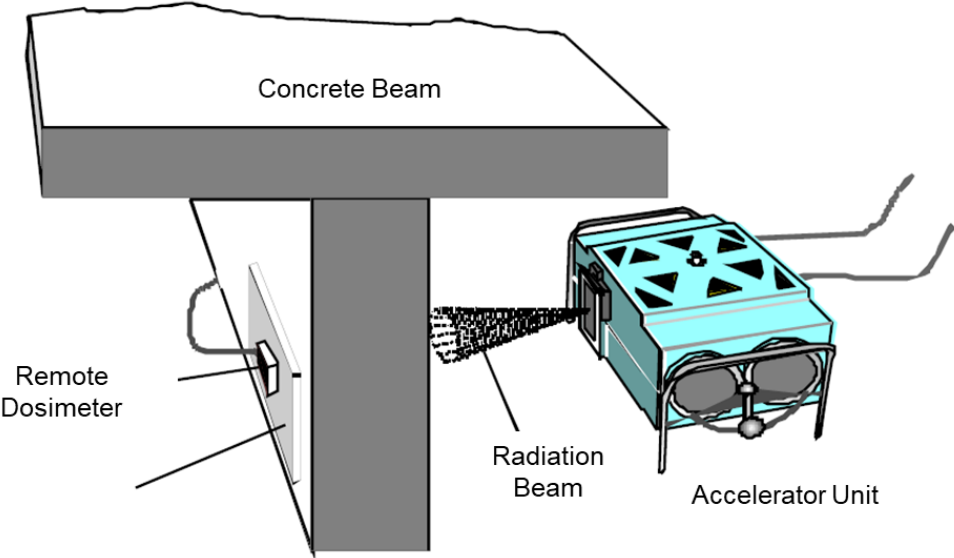
Figure B.5 Typical set up for radiography with a Betatron. The power and control units are separate. A 220 V, 15 A power supply is needed. The supply should be steady and not fluctuating, for example, due to the effects of welding or movement of heavy electrical machinery.

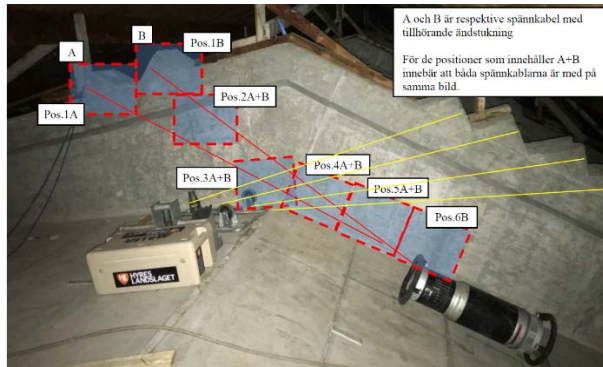
Equipment and different positions, by curtsey of DEKRA, 2019

In figure B.6 typical results from using the radiography method is shown. The ducts and the tendons can clearly been seen and in table B.5 the capabilities and limitations of the method is presented.

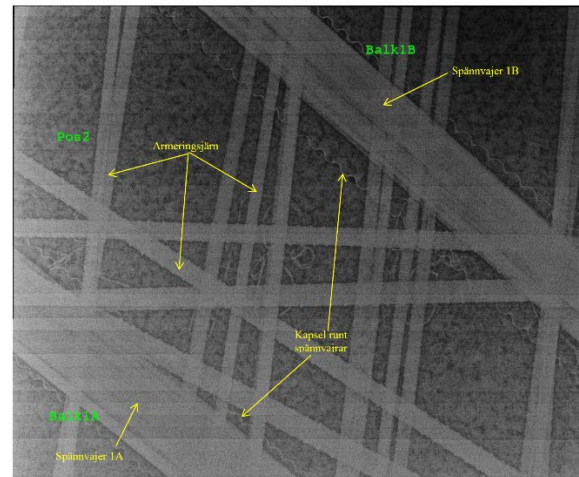
Results. The duct and the tendons together with steel reinforcement can clearly be noticed in the photo, by curtsey of DEKRA, 2019

Figure B.6 Example of results from the radiography method.

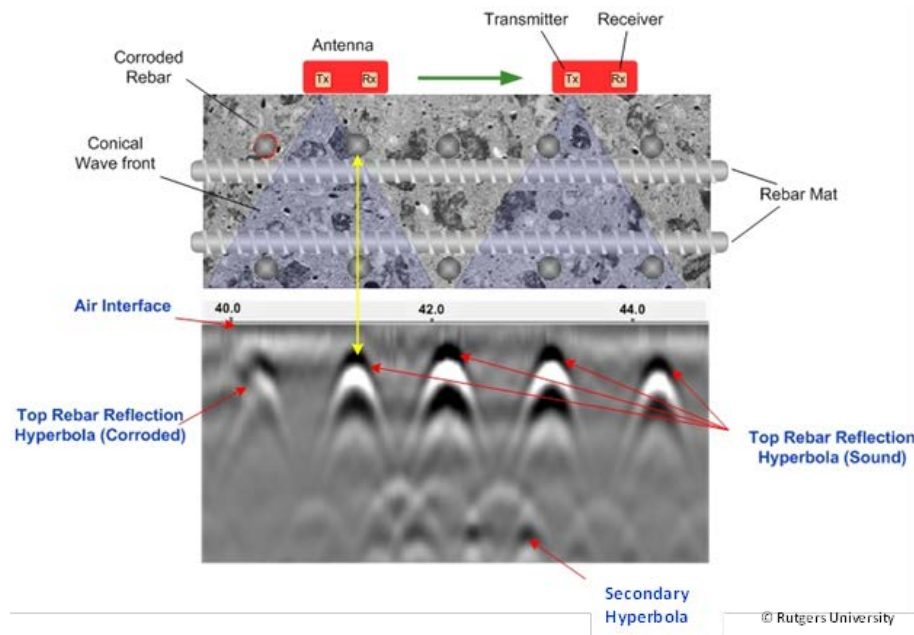
Figure B.7 Ground penetrating radar, from (https://fhwaapps.fhwa.dot.gov/ndep/DisplayTechnology.aspx?tech_id=25, 2019)

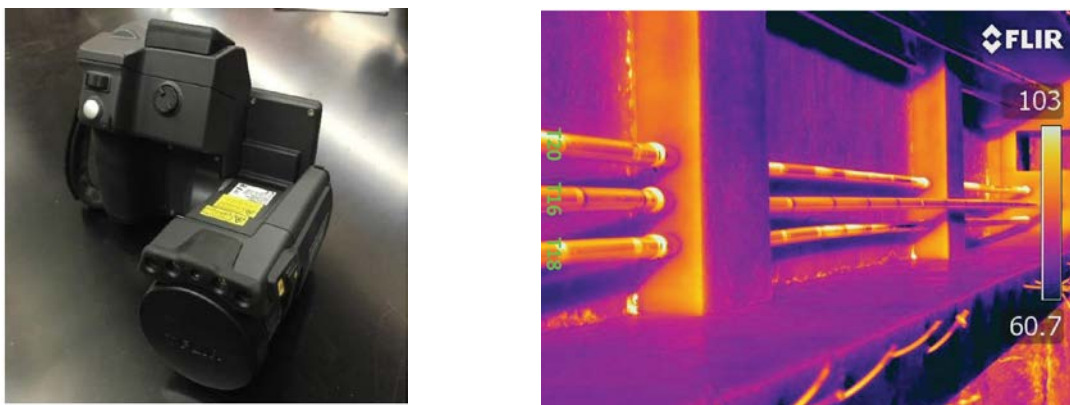
Figure B.8 IRT Technique using FLIR T640 Infrared Camera and sample of infrared image of external tendons, from (<http://nap.edu/24779>)

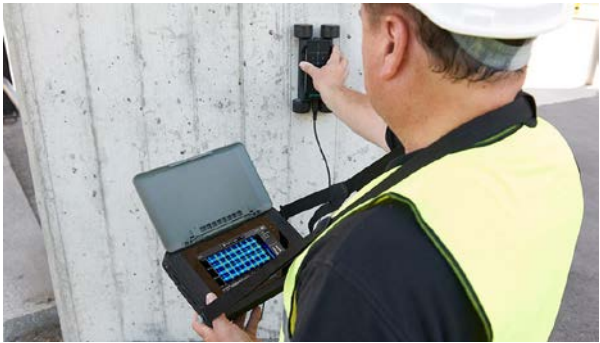
Figure B.9 Use of cover meter, from ([http:// www.proceq.com](http://www.proceq.com))

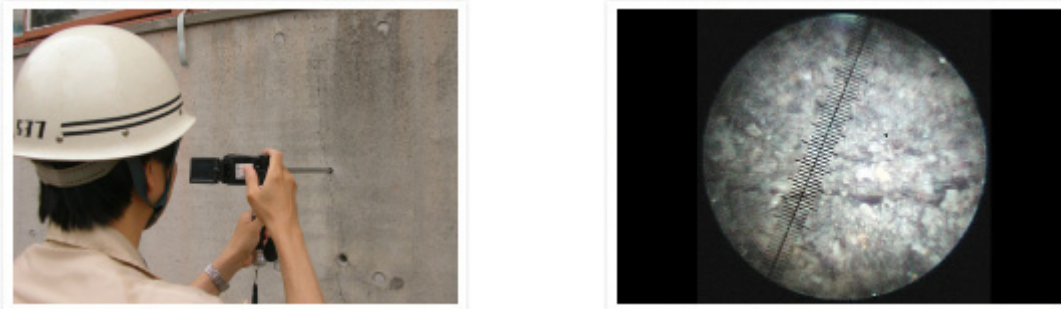
Figure B.10 Use of endoscope identifying a crack in concrete, from ([http:// www.nishimatsu.co.jp](http://www.nishimatsu.co.jp))

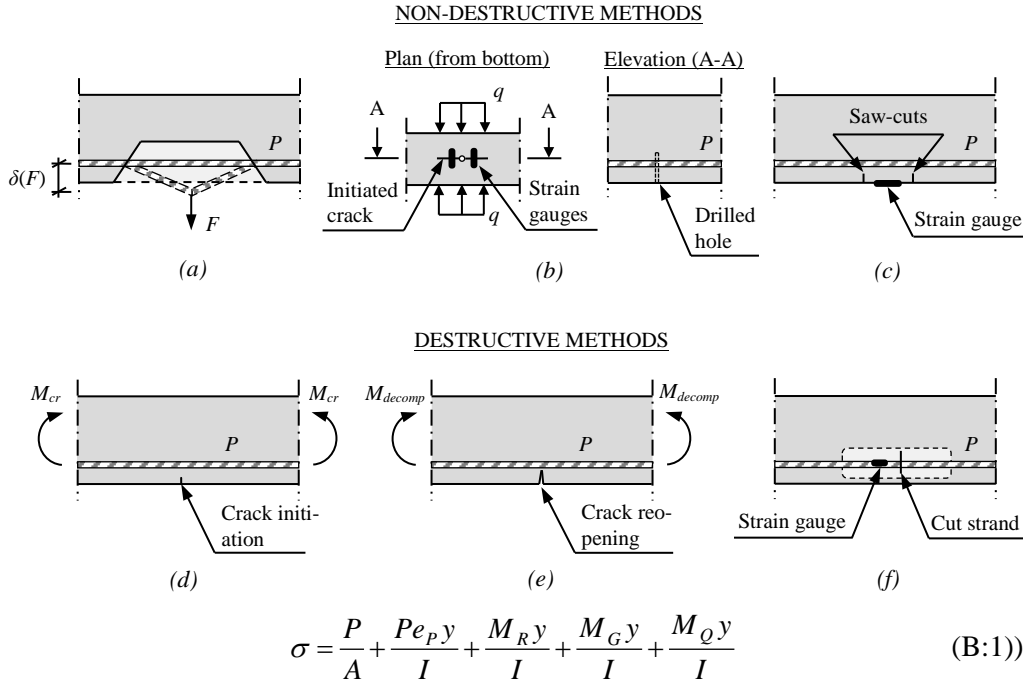
Figure B.11: Methods to determine residual prestress force P in concrete members experimentally: (a) exposed strand method, (b) drilled hole method, (c) saw-cut method, (d) crack moment method, (e) decompression-load method, and (f) strand cutting method; redrawn from Bagge et al. (2017).

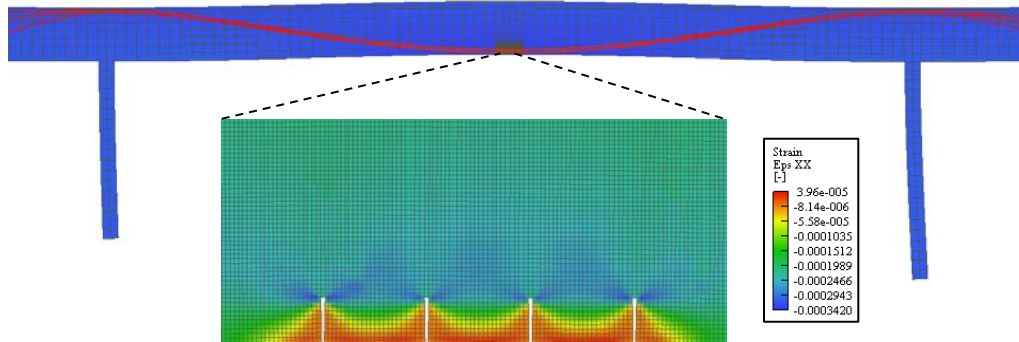
Figure B.12 A part of an FE model for simulation of the strain distribution as saw-cuts are introduced transversally at the base of a concrete beam (Bagge et al. 2017).

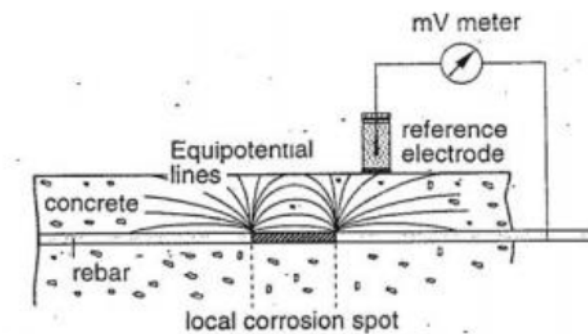
Figure B.13 Principle and main components of half-cell potential measurements. Reference electrode, high impedance voltmeter, connection to the rebar. Adopted from RILEM TC 154-EMC, (Elsner, 2003)

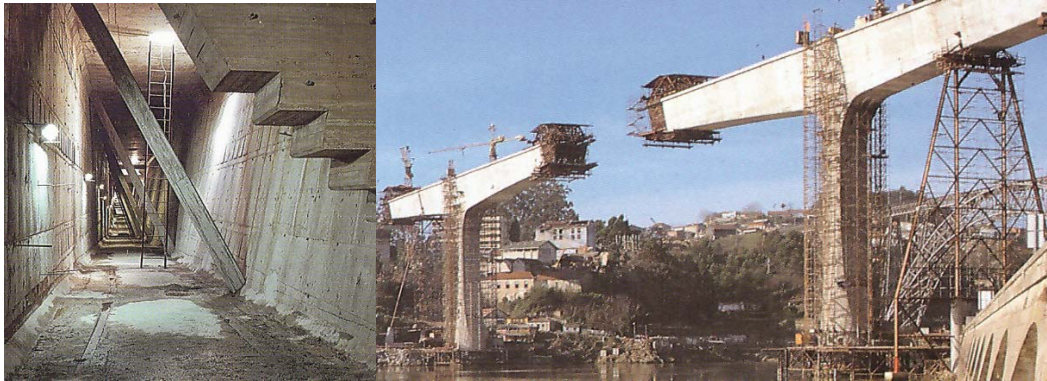
Figure C.5 Photos from the new railway bridge in Porto shows preparation for extra external post-tensioning, (Nova ponte ferroviaria sobre o Rio Douro no Porto)

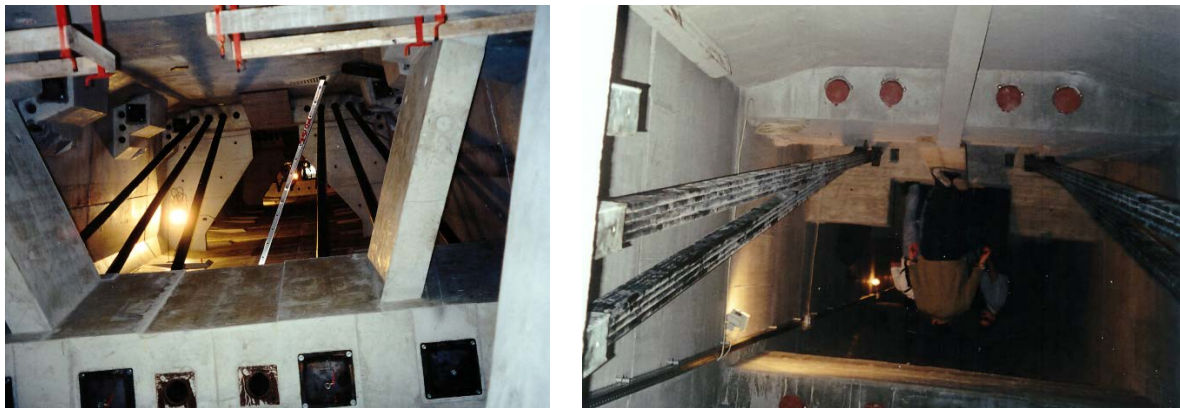
Figure C.6 Photos from a French bridge on high speed line to Marseille left and a Hungarian bridge on the new freight line through Slovenia to the Mediterranean (Photos by B. Paulsson)

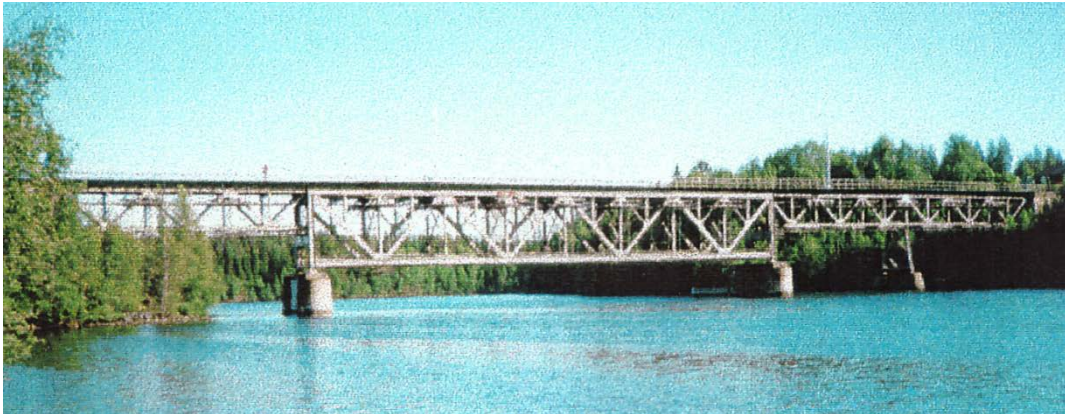
The two pictures above shows the bridge. (Björn Töyrä)

In 1996 Skellefte Älv bridged was strengthened due to increase of axle load from 22.5 tonnes to 25 tonnes. The bridge is a riveted truss bridge built 1911. The bridge has tree spans 24m + 60m + 48 m and was originally dimensioned for an axleload of 8 tonnes.

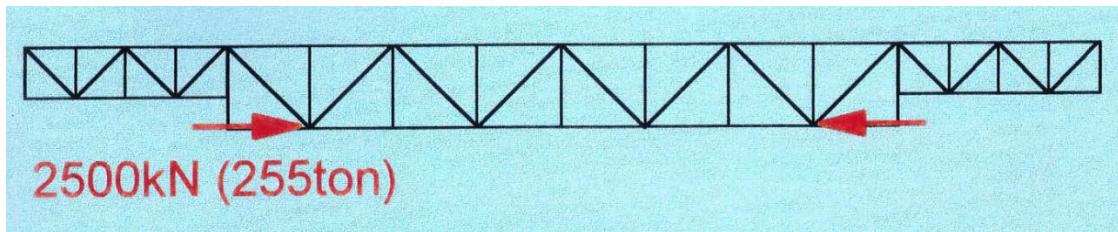
Figure AD,1 The figure shows how the forces was applied to the bridge.

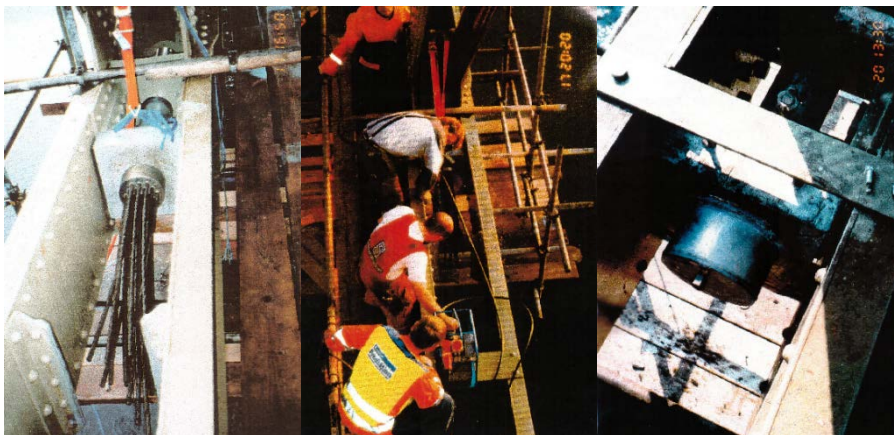
Figure AD.2 shows how the compresses was applied in detail, installation of anchors on the bridge and how it looks like after injection and sealing.

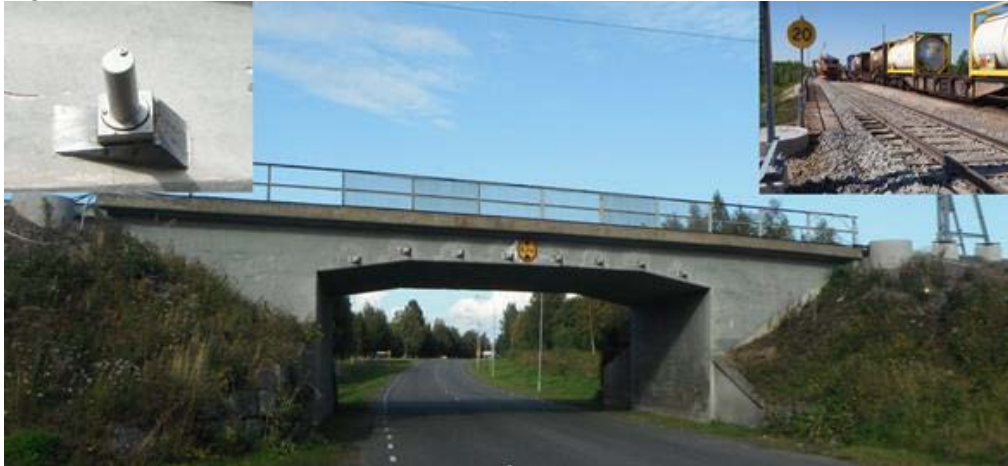
Figure D-x The Haparanda Railway Bridge (3500-2033-1, km1309+609) was strengthened in the summer of 2012. Eight transverse prestressing bars were installed at mid-height of the slab (left insert) and posttensioned to upgrade the axle load capacity of the railway line from 25 to 30 ton.

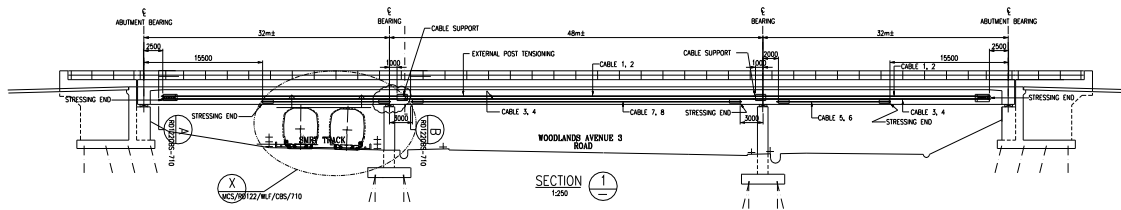
Longitudinal section. 3 systems of external prestressing cables are provided

The longitudinal girders were strengthened. The stresses in SLS as well as the Load capacity in sections at mid piers as well as in mid spans were adjusted. The ordinary prestressing system VSL was used with ordinary prestressing cables, ducts, anchorages and prestressing equipment was used. For each girder up to six cables were provided and prestressed on each side of the girder. The amount of the additional prestressing was of the same magnitude as the existing prestressing. Formal tensile stresses in the concrete of size 8 MPa was balanced by the external prestressing. The load bearing capacity in critical sections was increased by approx. 15 %. No traffic management needed as all construction works were above non traffic areas. The codes used was BS 5400 supplemented by the local (Land Transport Authority, Singapore) Bridge Design Criteria and VSL's normal guidelines for use of VSL prestressing systems. The alternatives were addition of a third main girder or using CFRP prestressed bonds at the underside of the main girders. Drawing and photos of the bridge are shown below.

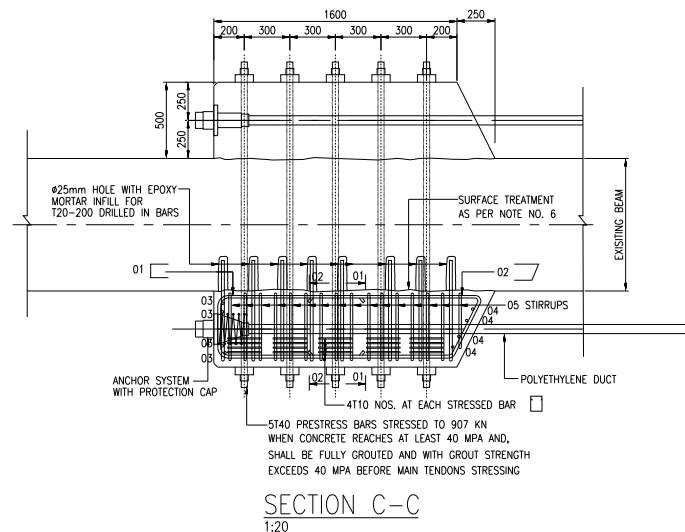
Anchor blocks. Plan section. Shear face with drilled in bars and with prestressed transverse bars

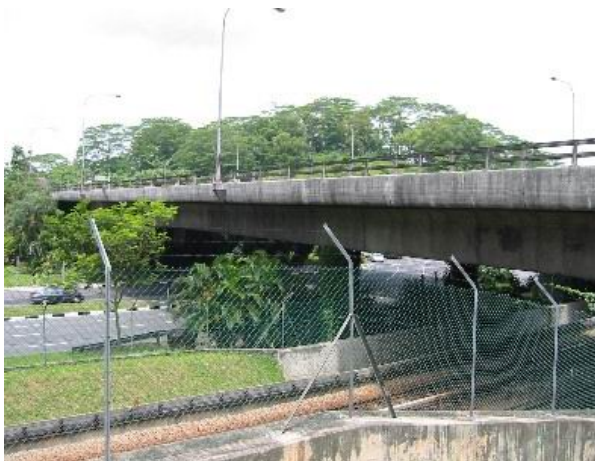
Woodland flyover. 3 span bridge with 2 main girders and bridge deck slab.

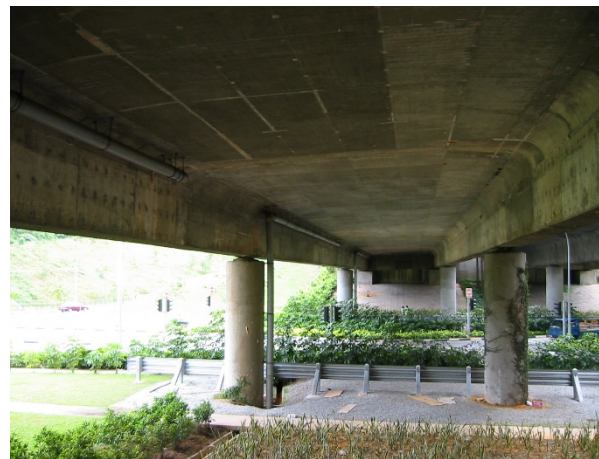
2 continuous main girders seen from below. Before external prestressing

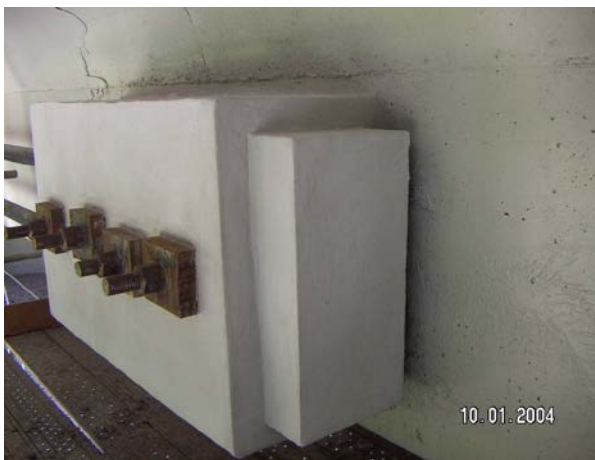
Anchor block for two cables. Shear face is prestressed by 4 transverse bars

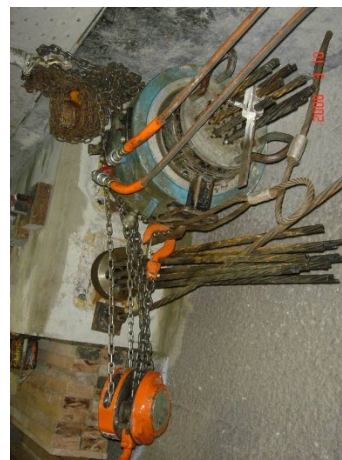
Prestressing of cable at top - "live end". "Dead end" for cable at bottom.
